Reducing Crack Potential in CA40

Daniel Harris

Steel Founders' Society of America
Technical & Operating Conference
December 7-10, 2022

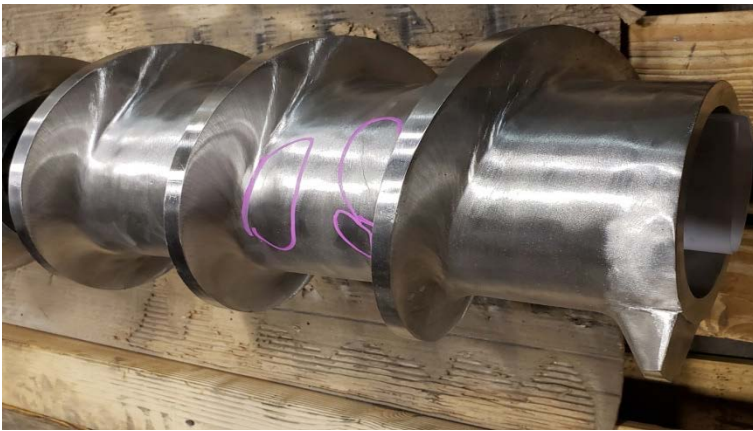
Figure 3- Visible cracks on near finished casting

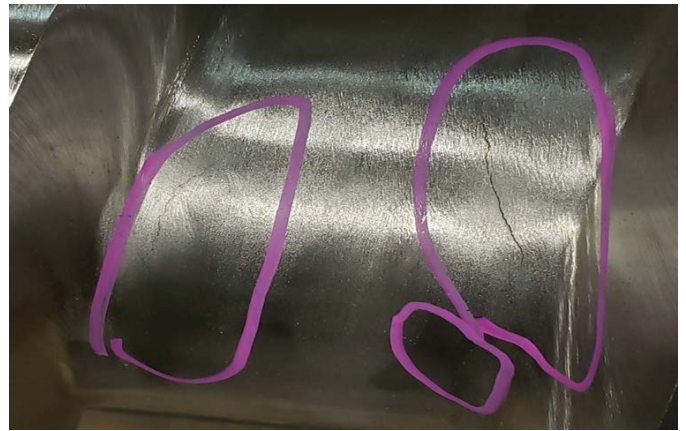
Figure 4- Visible cracks on near finished casting

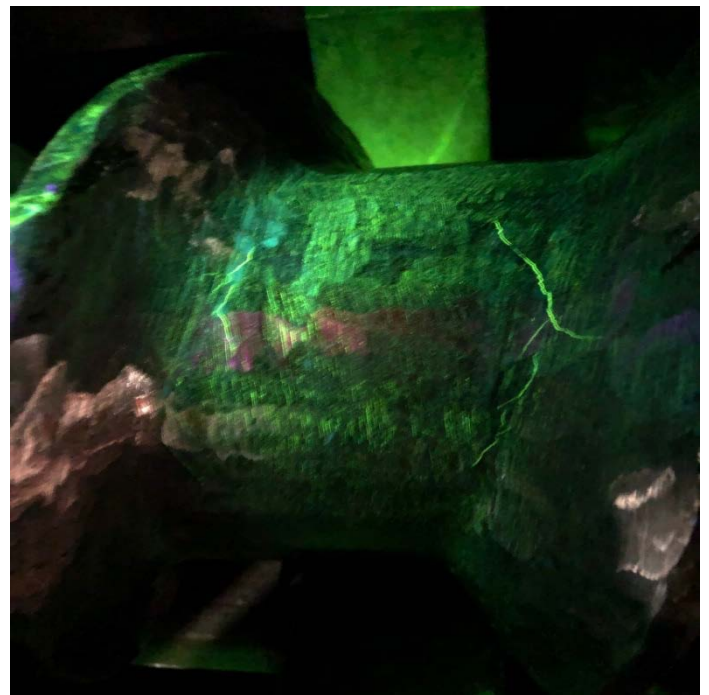
Figure 5 displays typical indications revealed under blacklight on a raw, in process casting. The jagged, nonlinear identity of the cracks can be noted as a modeled illustration to the cracks that were identified on most related CA40 castings. Occasionally, it was found that some cracks at the ends of the castings did break over into the inner diameter; however, due to the location, linear nature, and inconsistency, these were attributed at a greater degree to tearing issues related to possible constraints during solidification. It seemed that the bulk of the issues at hand correlated to riser locations.

Figure 5- Cracks on raw casting identified under blacklight

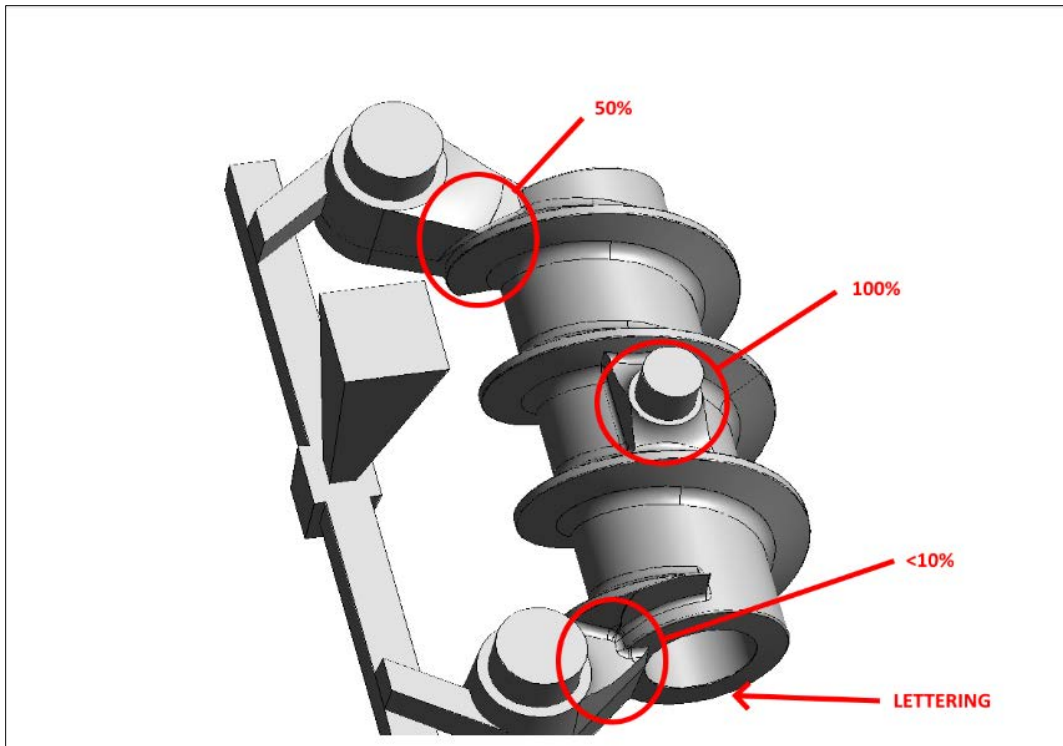
Figure 6 below illustrates the subject casting as rigged with the corresponding defect rates at each riser contact area. The end risers are 3 inches in diameter and the center riser is 4 inches in diameter but tapers down to a 2-inch contact area on a square pad. A collection of data was compiled from extensive in-process magnetic particle inspection to determine severity and location correlation of the cracks. The center riser location proved to be the most consistent, as 100% displayed cracks in this region. Somewhat interestingly, it was observed that this is the shortest riser of the three. The riser to left side of the sprue, which has a slightly larger contact area than that of the right, exhibited roughly a 50% crack rate, and the riser to the right of the sprue displayed a mere 10% or less. It was unclear at this point whether the observed crack rates correlated to overall riser sizes. It was speculated that increasing height or diameter of some of the risers may reduce cracking potential if the cracks were somehow shrink induced. However, due to the magnitude and consistency across a plethora of different parts, it was found unreasonable to pursue such an action without further investigation.

Figure 6- Approx. defect rates/ rigging model

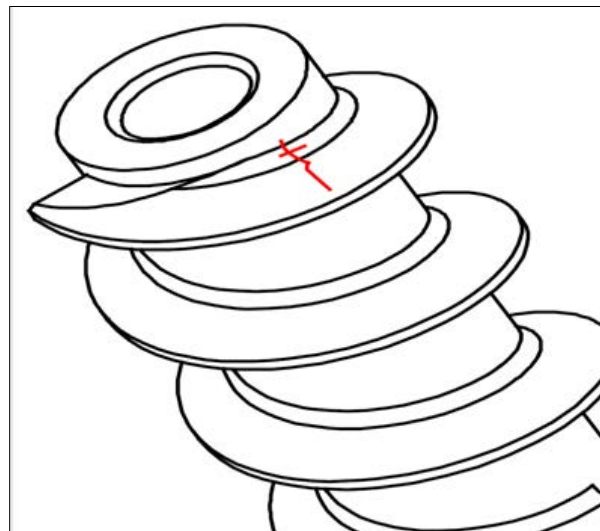
A sample was chosen for mechanical excavation to determine representative depth. The original indication identified on a contact area appeared as axial running down the top flight with a smaller transverse indication at the radius of the flight and body intersection. Figure 8 details the excavation of the subject casting. The excavation revealed that there is a sub-surface continuation and networking of the cracks at various depths.

Figure 7- Top section illustration of original indication.

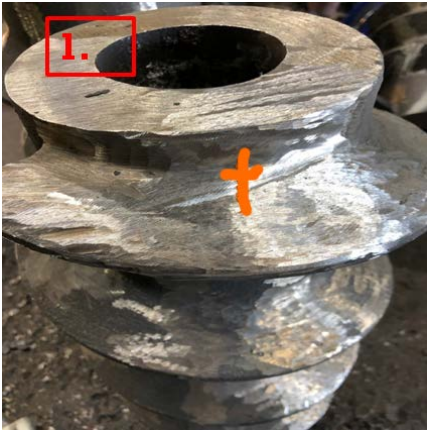
- Original Indication

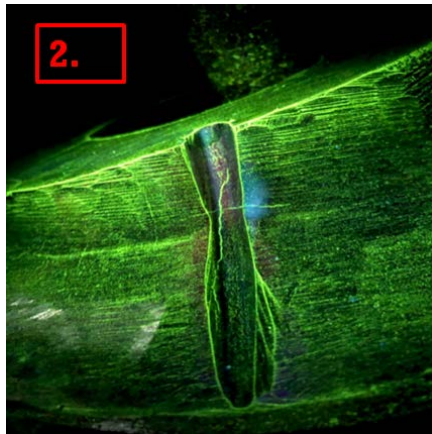
- Excavated to approximately 1/8" depth

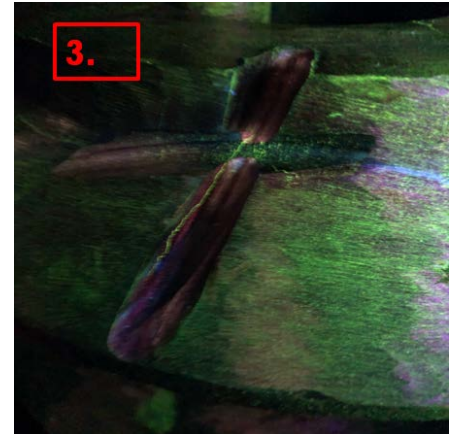
- Primary axial crack excavated to 3/16" and perpendicular to 1/8"

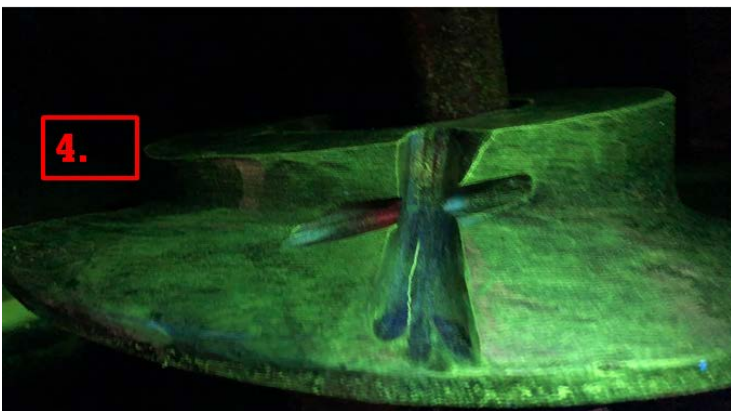
- Perpendicular crack seems to disappear, and primary axial crack seems to be moving down flight.

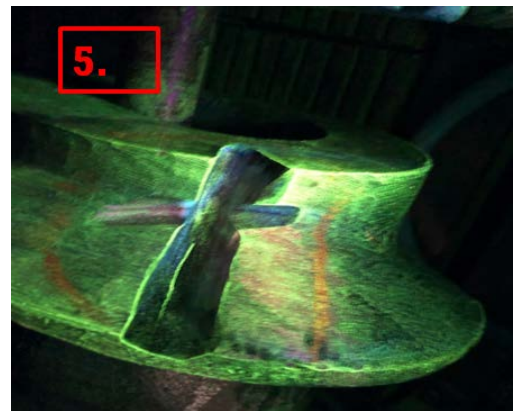
- Primary axial crack excavated to approx. 1/4". Location seems the same.

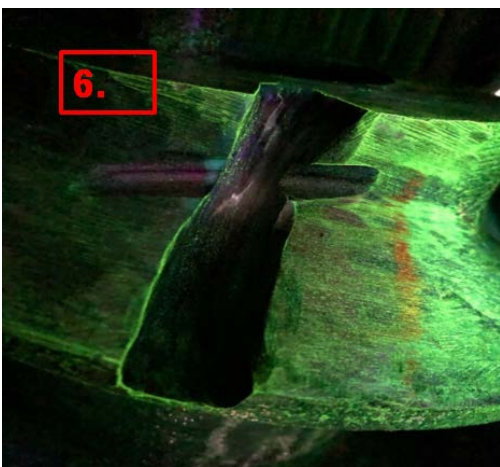
- Crack completely removed at 1/2" material depth.

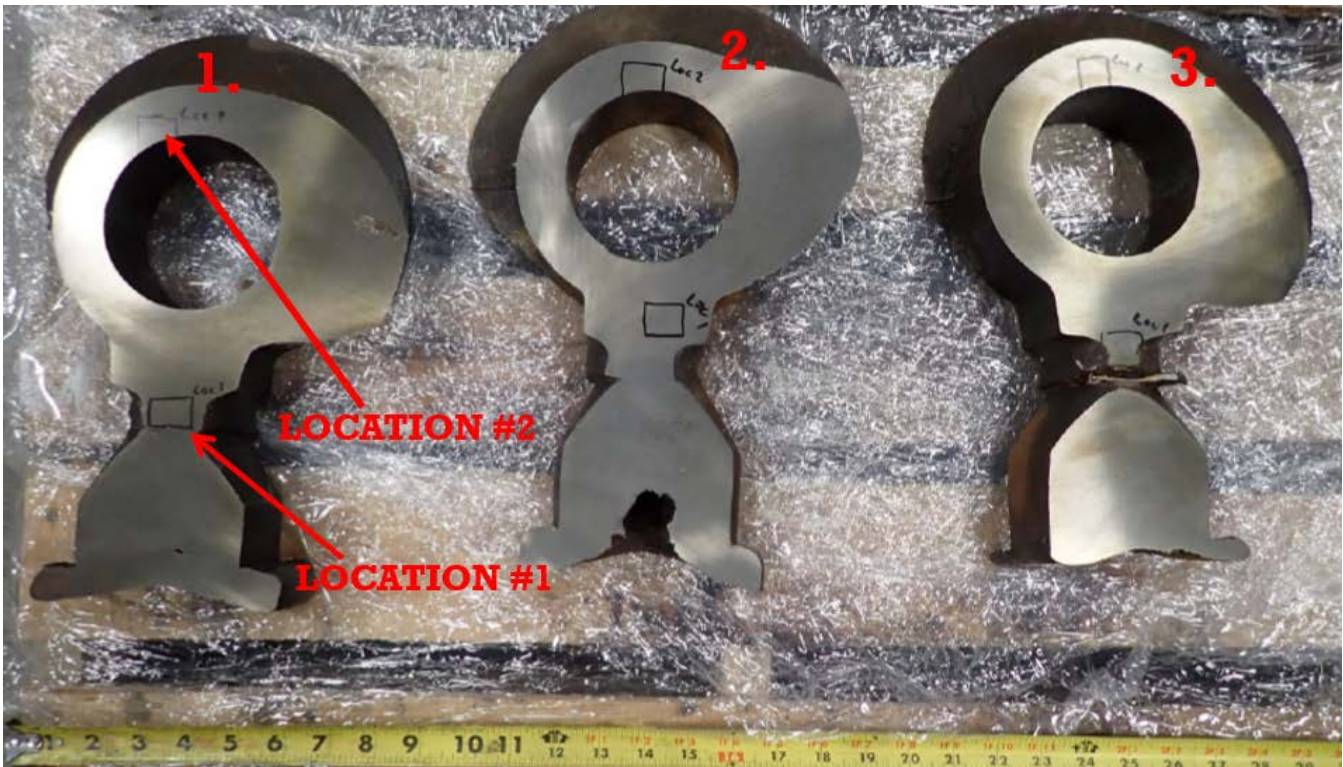
After NDT, the specimens were surface ground and macroetched to reveal any discontinuities. Figure 11 below displays the cut sections, which are arbitrarily identified 1-3 from left to right. Two locations were reviewed on each sample. Location 1 was taken at the subject problem area, adjacent to the riser. Location 2 was used as a control and was taken opposite of the riser, adjacent to the center radius (ID). Both locations exhibited very similar features and data on all [3] samples both visually, and via metallographic and SEM/ EDS, so sample #2 was used for documentation purposes in this report. Visually evident discontinuities were identified at both locations and were sectioned for further analysis.

Figure 11- Cut sections, visual examination, macroetch results

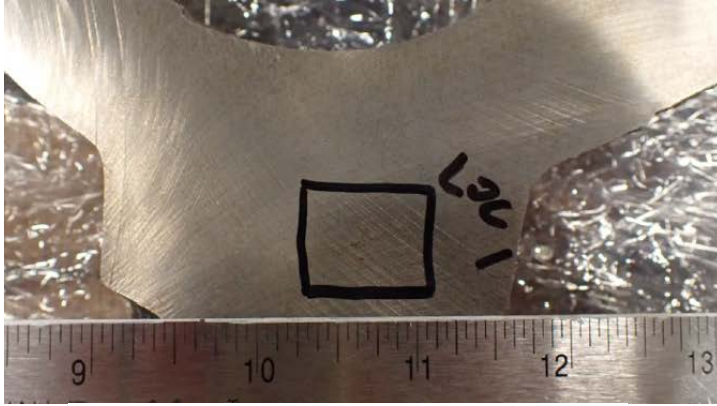
Location #1 (Figure 12 below) exhibits a darker etching microstructural component adjacent to the riser, which is quite typical in most steel castings. Location #2 (Figure 13 below) did exhibit very fine porosity, but likely much better than that of a level 1 RT.

Figure 12- Location #1: adjacent to riser

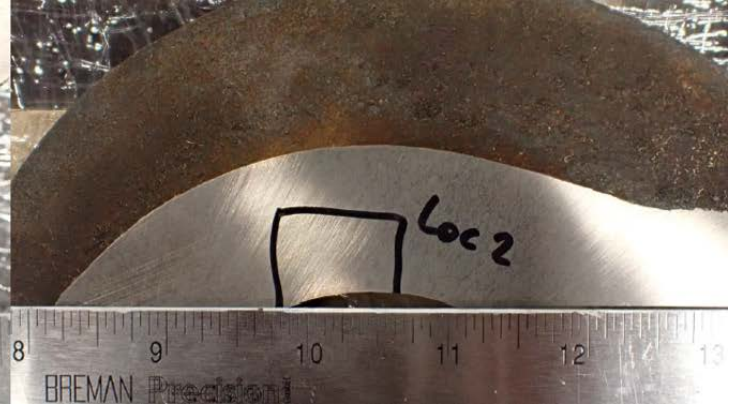
Figure 13- Location #2: opposite of riser

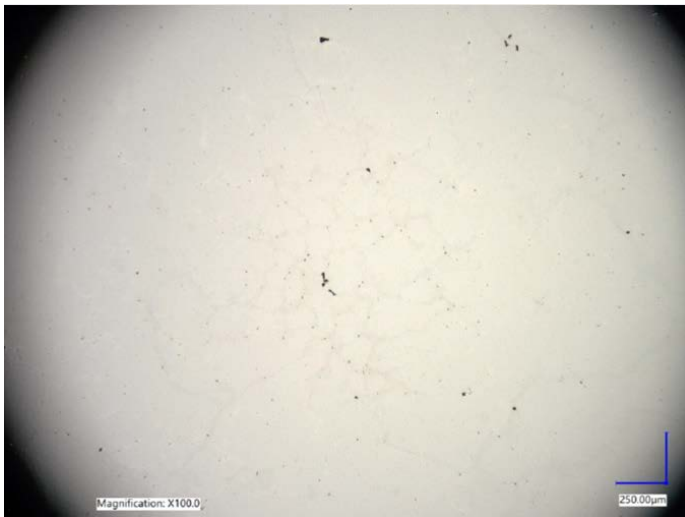
An interdendritic networked phase was observed at location #1. This location also contained manganese sulfide and titanium carbide inclusions, as well as some very minor under riser shrink. The sporadic titanium carbide inclusions were not of concern since titanium is deliberately added to control nitrogen. As well, the manganese sulfide inclusions were found infrequent. Energy dispersive spectroscopy (EDS) was conducted at both locations noted in figure 15 below. Location 1 (EDS 1) was taken right at the networked boundary and was found to have extremely elevated carbon and chromium. Location 2 (EDS 2) was found to have elevated carbon and manganese at the inclusion. Tables 3 and 4 detail results of EDS.

Figure 14- Location 1, magnification: X100

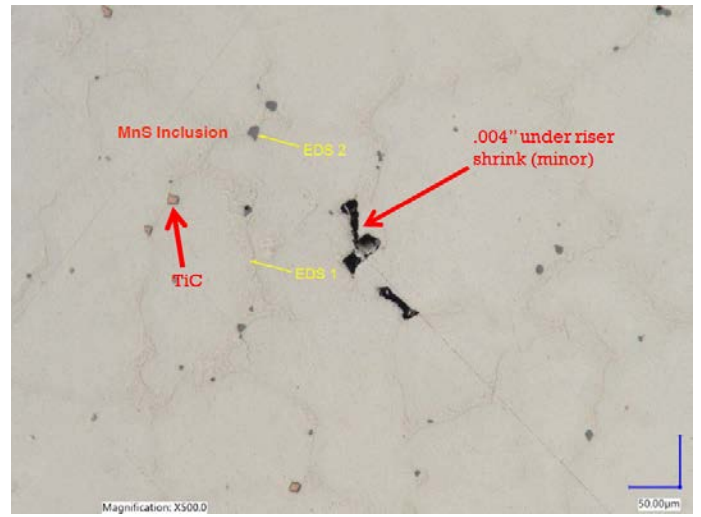
Figure 15- Location 1, magnification: X500

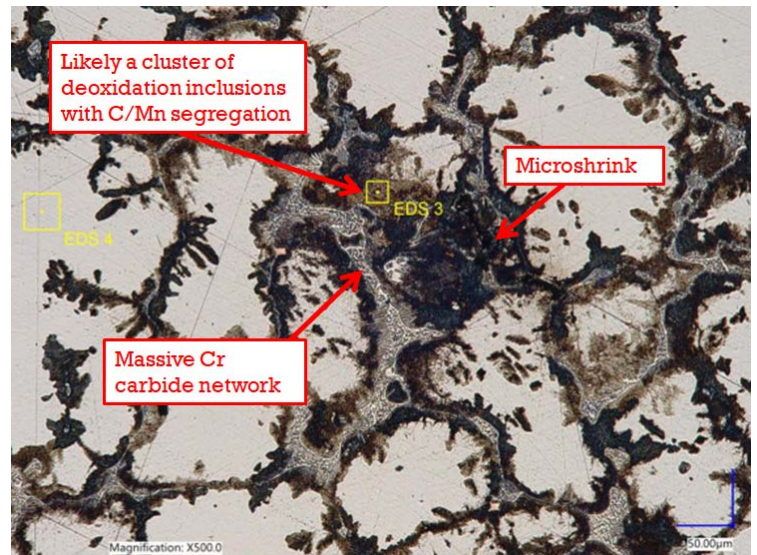
The location 1 sample was then etched with Vilella's Reagent, and a darker network was observed. Figure 17 shows locations of EDS 3 and 4, both of which contained elevated carbon, manganese, zirconium, and oxygen.

Figure 17- After etching, magnification: X500

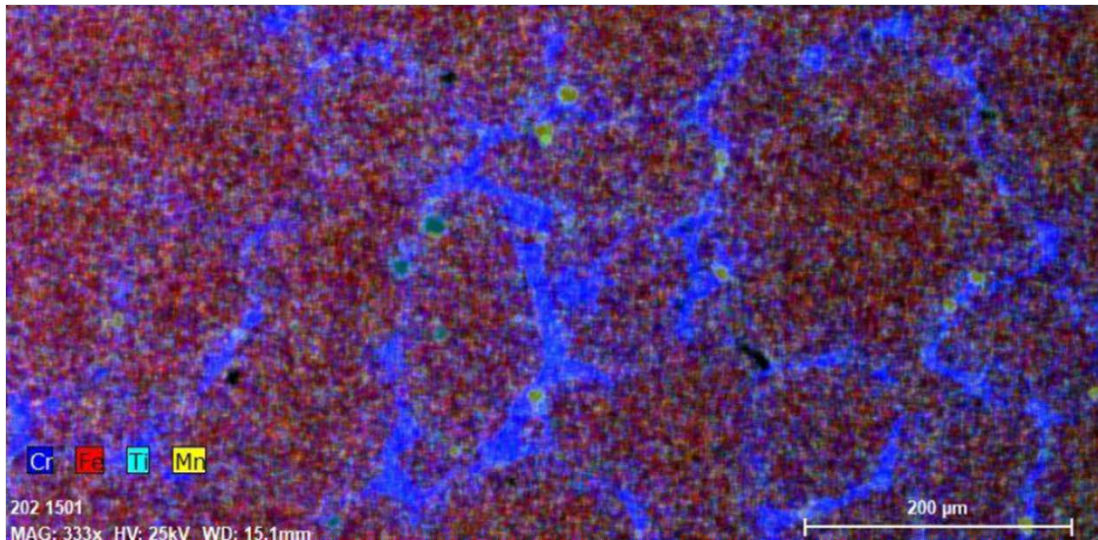
Color coded EDS mapping shown in Figure 18 below displays the highly elevated chromium content in the interdendritic network (blue), which is likely resultant of riser segregation. The remainder of the element matrix appears to be well distributed. All three casting samples exhibited very similar segregation in this region.

Figure 18- Location 1, EDS mapping

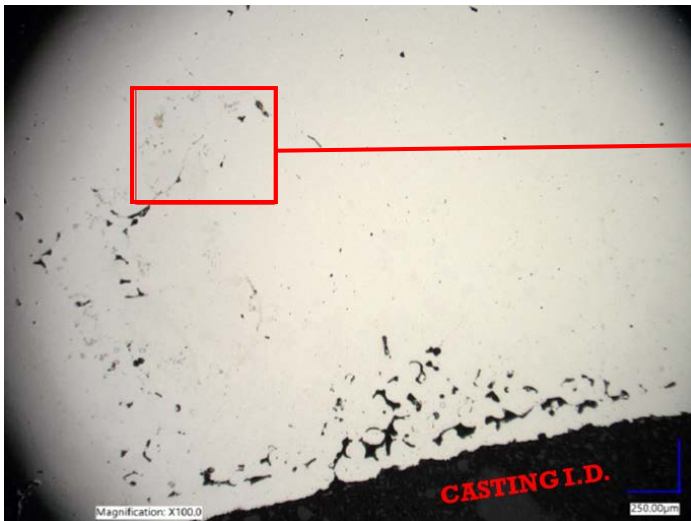
Several peculiar discontinuities within this region were reviewed in additional analysis. It seemed that the bulk of these inclusions were oxidation related to some extent or another. EDS 1 revealed elevated titanium, aluminum, and zirconium (aluminum and titanium are deoxidation additions). EDS 2 revealed elevated titanium, nitrogen, and oxygen and is probably another deoxidation cluster. The crack-like feature at EDS 3 is somewhat unclear without further analysis: it may be minor cracking between inclusions and microshrink, however, more likely may be carbide precipitation at grain boundaries; this area resulted in elevated aluminum, oxygen, and manganese.

Figure 19- Location 2, magnification: X100

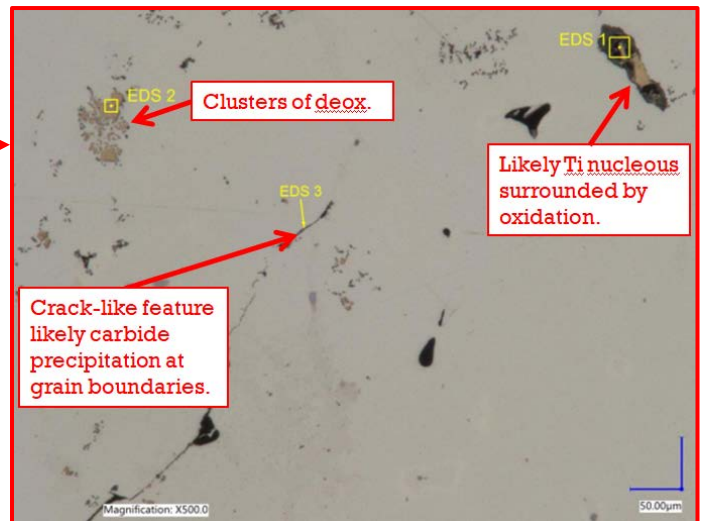
Figure 20- Enlarged view of red boxed area shown in Figure 19. magnification: X500

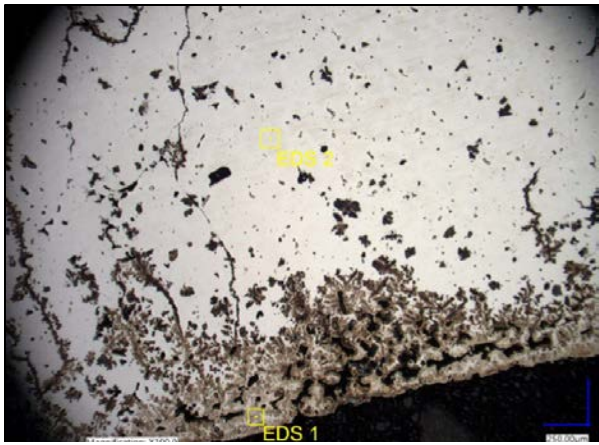
EDS results at location 2 revealed elevated carbon, phosphorus, and oxygen. This, in conjunction with the observed micro shrink previously mentioned is likely due to diffusion of the mold and probably does not correlate to the interdendritic phase observed in location 1 (subject area), adjacent to the riser. Figure 20 below details results after etching, as well as locations of EDS 1 and 2.

Figure 21- Location 2 after etching. magnification: X100

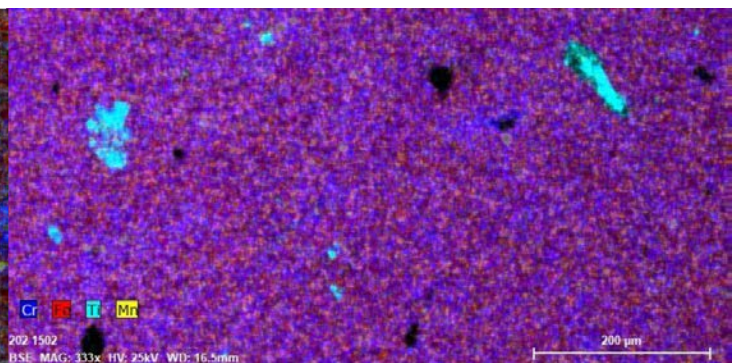
Despite several observed factors related to overall material cleanliness, there was no chromium carbide precipitation present at location 2, as compared location 1. Overall, this area exhibited a well homogenized elemental distribution. Figures 18 and 22 below display a direct side-by-side comparison of color-coded EDS mapping to illustrate the drastic difference in the locations.

Figure 22- Location 2, EDS mapping

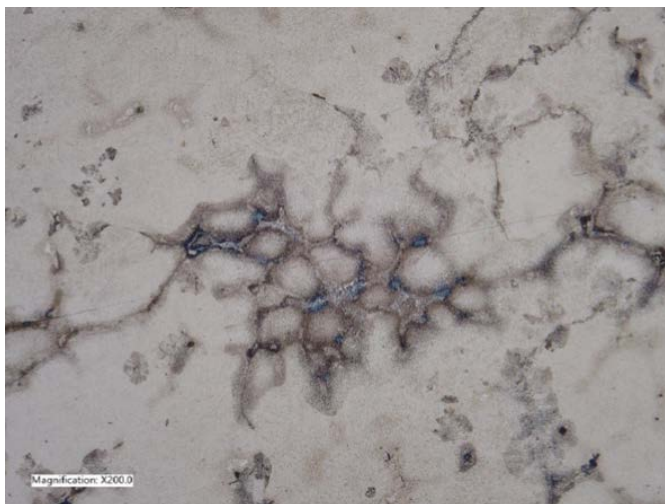
The heat-treated specimens were then etched using Vilella’s reagent and re-evaluated. Figures 23 and 24 below display results from sample 3, which are representative of results from samples 1 and 2; all three samples displayed very similar features. The microstructure in sample 1 consists of martensite and bainite with some inclusions, chemical segregation, and a lingering tenacious carbide network. Sample 2 contained the best structure of the three samples, which consisted predominately of martensite with interdendritic inclusions, chemical segregation, and an aggressive carbide network, however, less than that of samples 1 and 3. The microstructure in sample 3 consisted predominately of martensite with chemical segregation and yet another remaining large carbide network.

Figure 23- Sample 3, etched. magnification: X200

It can be concluded that following the aforementioned heat treatment, no significant solutionizing of the interdendritic carbides and chemical segregation were visually evident in samples 1 and 3. Sample 2 did exhibit some evidence of solutionizing in comparison to the previously analyzed in the as-cast state, however only to a very minor extent; the carbide network and chemical segregation remained seemingly aggressive.

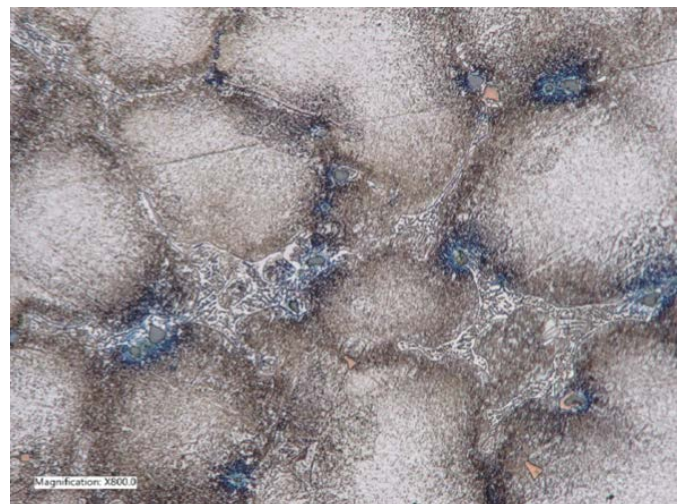
Figure 24- Sample 3, etched. magnification: X800
