**CORRELATION OF DESTRUCTIVE
TESTING OF STEEL CASTINGS
WITH STRESS ANALYSIS AND
MECHANICAL PROPERTIES**

PART I-A Summary Report

A Research Project at Case Institute of Technology

Steel Foundry Research Foundation

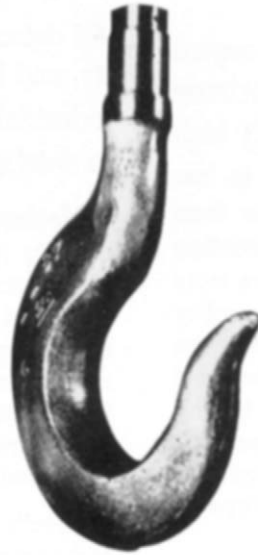
HOOK

TEST SPECIMEN LOCATIONS AND TYPES AND LOCATIONS OF DEFECTS

TESTED CASTING SHOWING STRESS COAT PATTERN AND FAILURE

The crane hook steel casting was designed with a safety factor of four for a capacity of 5 tons. A summary of the condition and performance of the production casting is presented in Figure 1. A Class 3 shrinkage defect (C-3) was located in the neck of the casting while a Class 1 porosity (A-1) was apparent near the point of the hook. Test bars were removed from these and other critical areas in the casting to determine tensile and impact properties. Comparison of these results with those obtained from separately cast coupons showed that in sound areas of the hook casting the tensile strength was 90 percent of the control (coupon) specimens while the elongation in the casting was reduced from 15.4 to 10.4 percent. Specimens which included the shrinkage discontinuity in the casting neck were

The hook was given brittle lacquer and strain gage tests before the casting was tested to destruction. Failure took place where the stress analysis indicated was the position of maximum stress concentration. Furthermore, failure did not occur in the area of the low mechanical properties as indicated by tests taken from the casting. Also, in no instance did failure occur through one of the discontinuities detected by radiography.

Breakdown tests conducted on these castings demonstrated that the discontinuities did not exert a discernable influence on the ultimate performance of the hook. The yield strength was first reached on the tension side of the hook throat during simulated testing. In five separate tests, the lowest applied load at which this yielding occurred was 35,000 pounds. Subsequent deformation first became visually apparent at values of applied load varying from 40,000 to 48,000 pounds. This deformation continued in the throat of the casting until failure resulted at this location at applied loads of 101,000 to 111,000 pounds. The load to failure is 10 times the service load of 10,000 pounds.

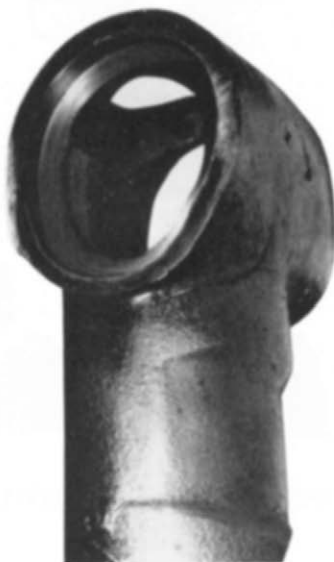
TRUCK AXLE

TEST SPECIMEN LOCATIONS AND TYPES AND LOCATIONS OF DEFECTS

The steel casting truck axle shown in Figure 5 was designed for use on a 1 1/2-ton truck. This type of service application included a static load of 4500 pounds on each axle and undetermined dynamic loads. Radiographic examination of the casting revealed Class 1 blowholes (A-1) near the fillet of the flange and Class 1 cracks (E-1) in the shaft near the opening for the king pins. Specimens were machined from a position near the mid length of the shaft and from the flange. Mechanical properties at both of these locations were somewhat lower than those obtained with separately cast coupons. However, the toughness was nearly identical for both types of specimens, with the energy level of

Breakdown tests were conducted to simulate the normal static load on the axle. The flange fillet attained the yield strength of the material on the tension side of the casting at an applied load of 8,000 pounds. However, substantial deformation was not observed in the axle even at an applied load of 50,000 pounds. The test was stopped at this load because the bolts which normally supported the casting failed. This occurred in spite of the fact that special heat-treated bolts were used for this test. Casting discontinuities did not appear to affect the performance of the axle at the applied load of 50,000 pounds which was considerably in excess (11 times) of normal service loads of 4500 pounds.

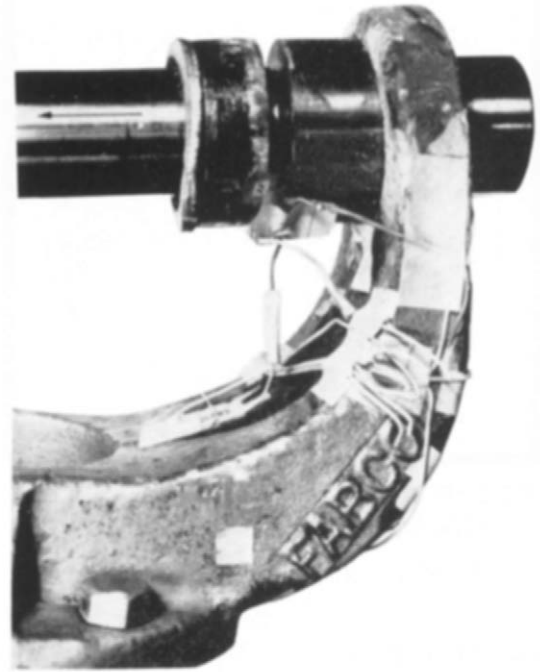
TESTED CASTING SHOWING FAILURE

Breakdown tests were conducted to simulate the vertical static loading conditions on the casting. Two suspension yokes were tested simultaneously by applying the load to the ring supporting the lower bearing race. Both castings failed by shearing the ring at a total load of 120,000 pounds (approximately 60,000 pounds per casting). The yield strength of the material was reached at a load of 24,000 pounds per casting by gages directly below the ring. Modifications of the casting to accommodate the test fixture were believed to have resulted in somewhat premature yielding at this location. The second area to experience yielding was on the compression side of the yoke at an applied load (per casting) of 32,000 pounds. The load to failure of 60,000 pounds is 13 times the service load of 4,500 pounds.
