**THE EVALUATION OF DISCONTINUITIES
IN COMMERCIAL STEEL CASTINGS BY
DYNAMIC LOADING TO FAILURE
IN FATIGUE**

**A RESEARCH PROJECT AT CASE INSTITUTE
OF TECHNOLOGY**

Steel Foundry Research Foundation

Rocky River, Ohio February, 1967

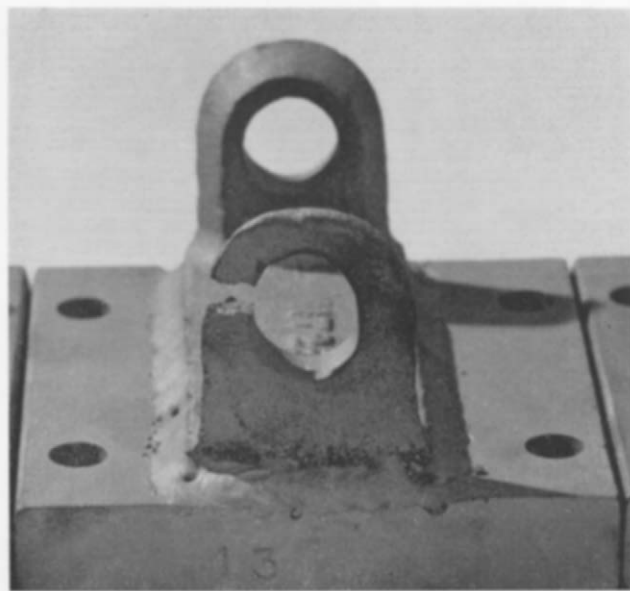
LOCATION OF THE FATIGUE FAILURES FOR THE SHEAVE HOLDER CASTING AND ALSO SHOWING SURFACE SHRINKAGE AT THE FILLET AREA

The stress analysis indicated that the maximum stress area is located in the cored hole region and not in the fillet area where most of the discontinuities were present. Since all the sheave holder castings failed through the cored hole region surface, surface discontinuities at the fillet area, usually a critical location, exerted no influence on the fatigue properties of the casting. However, surface discontinuities present in the cored holed region were detrimental to the fatigue properties of the casting. Therefore, surface discontinuities are detrimental to the fatigue properties only if located in the areas of maximum stress.

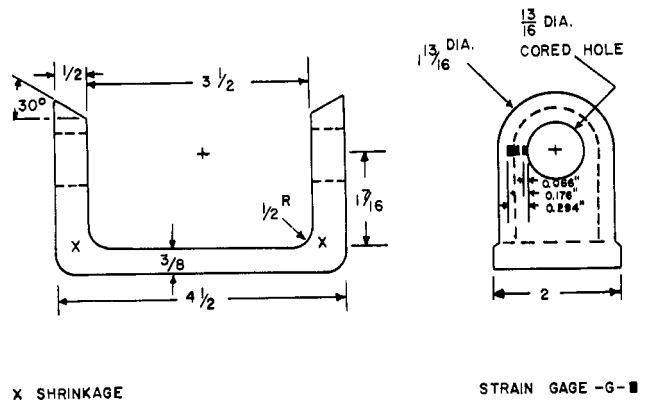
DIMENSIONS OF SHEAVE HOLDER WITH LOCATION OF STRAIN GAGES AND DISCONTINUITIES

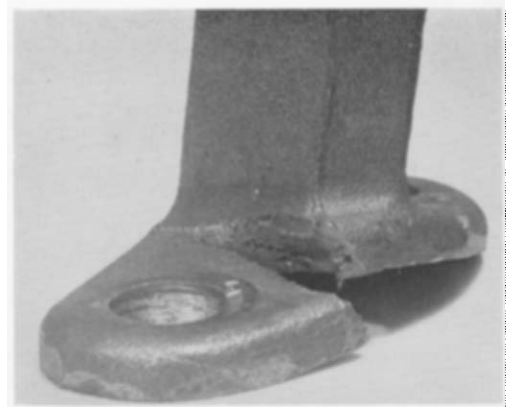
LOCATION OF FATIGUE FAILURE IN FULCRUM BRACKET

All the Fulcrum Bracket castings failed in fatigue and tension through the front fillet region, surface discontinuities located in the rear fillet exerted no influence on the fatigue properties of the casting. Thus, the results of the tests on the Fulcrum Bracket casting indicate that prominent surface discontinuities as located by visual and magnetic particle inspection were not detrimental to the fatigue properties of the casting since they were not located in the areas of maximum stress.

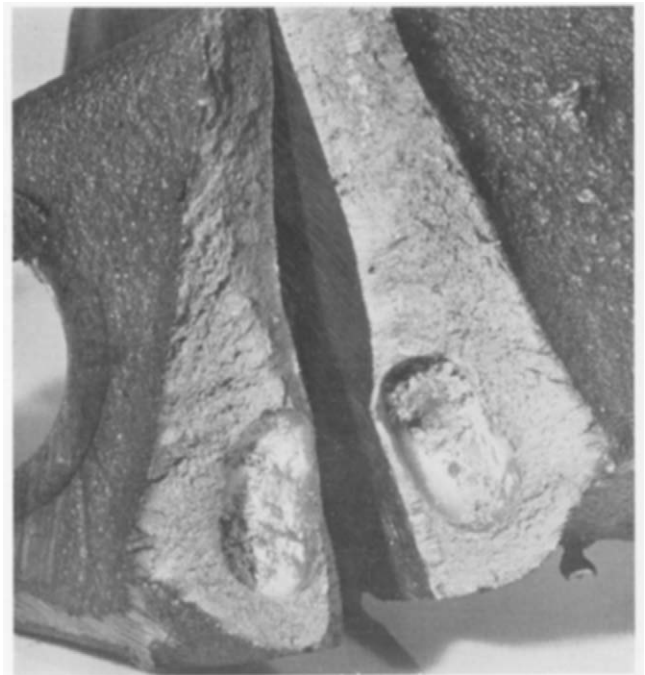
SEVERE GAS POROSITY IN BASE OF FULCRUM BRACKET

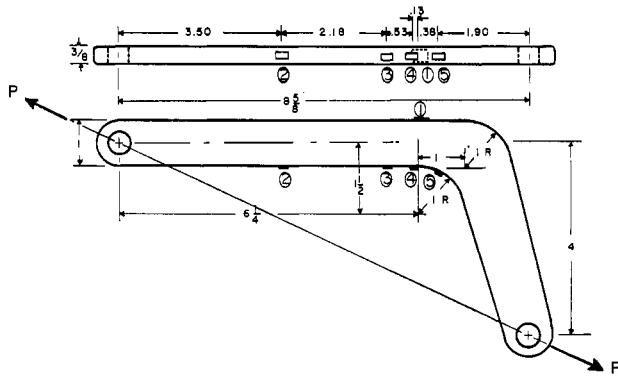
DIMENSIONS OF HANGER CASTING AND LOCATIONS OF STRAIN GAGES AND DIRECTION OF LOADING

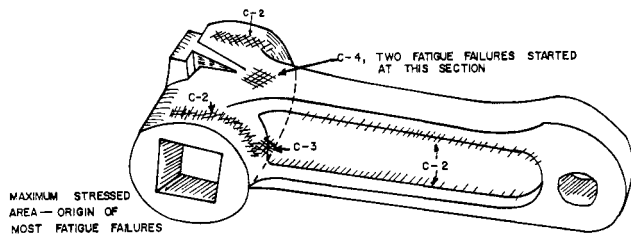
LOCATION AND SEVERITY CLASS OF DISCONTINUITIES IN THE LEVER CASTING

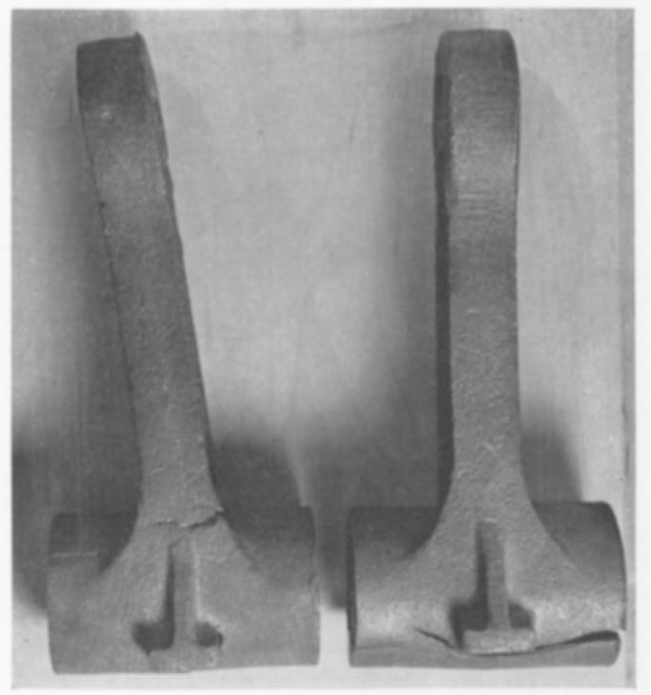
TYPES OF FATIGUE FAILURE FOUND IN THE LEVER CASTINGS

All Lever castings on test to failure in fatigue developed fatigue cracks at the location of stress concentration and all but two failed as a result of propagation of these fatigue cracks. The two Lever castings which did not fail by growth of these cracks were tested at very high loads with the fatigue failure occurring at the junction of the lever arm and the barrel at a position of a pronounced shrinkage area which was near the casting surface. Otherwise, the presence of

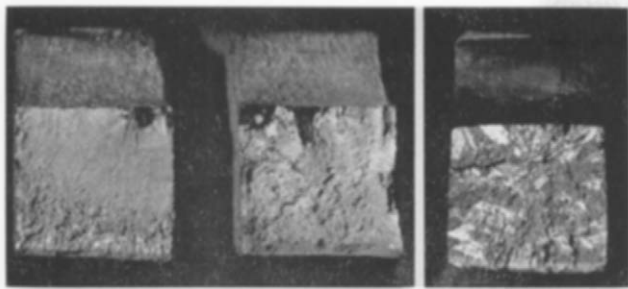
FRACTURE SURFACES OF TRIP LINK CASTINGS BROKEN IN FATIGUE AND STATIC LOADING

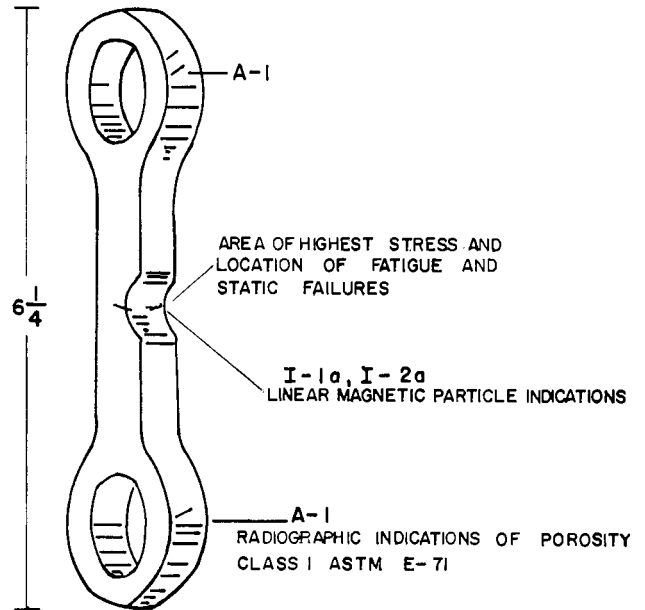
POSITION AND SEVERITY OF DISCONTINUITIES IN TRIP LINK

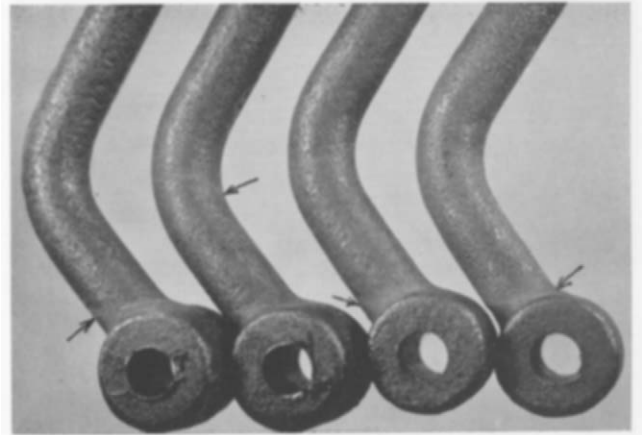
MAGNETIC PARTICLE INDICATIONS OF FATIGUE FAILURES IN HINGE CASTINGS TESTED IN FATIGUE

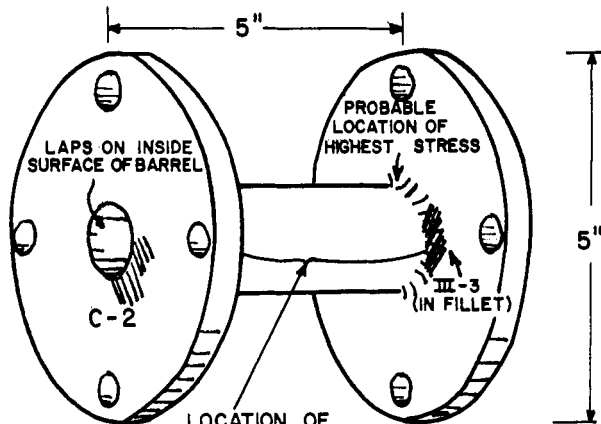
- LOCATION OF FATIGUE FAILURES; DISCONTINUITIES OF TYPE III-3, V-1
- C-2 : RADIOGRAPHIC INDICATIONS OF INTERNAL SHRINKAGE TO CLASS 2, ASTM E-71
- III-3 : MAGNETIC PARTICLE INDICATIONS OF INCLUSIONS TO DEGREE 3, ASTM E-125
- V-1 : MAGNETIC PARTICLE INDICATIONS OF POROSITY TO DEGREE 1, ASTM E-125

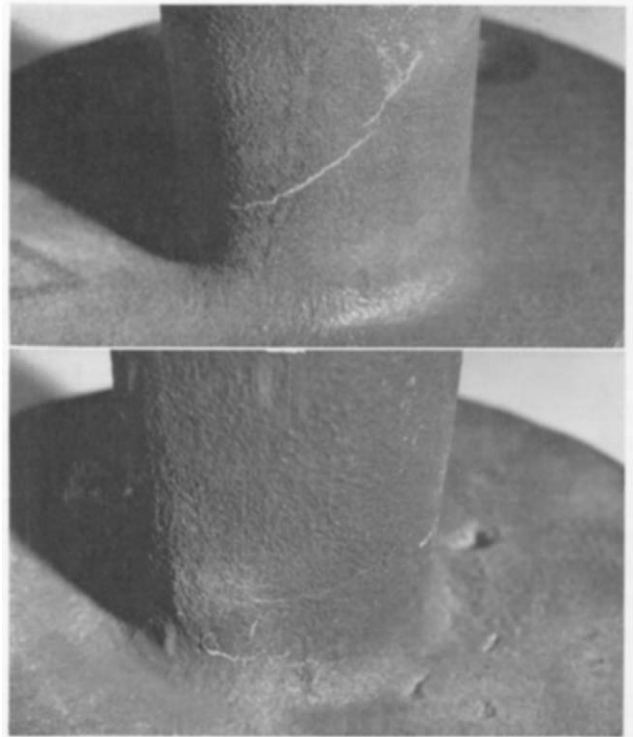
MAGNETIC PARTICLE INDICATIONS OF TYPICAL FATIGUE FAILURES IN FLANGE CASTINGS

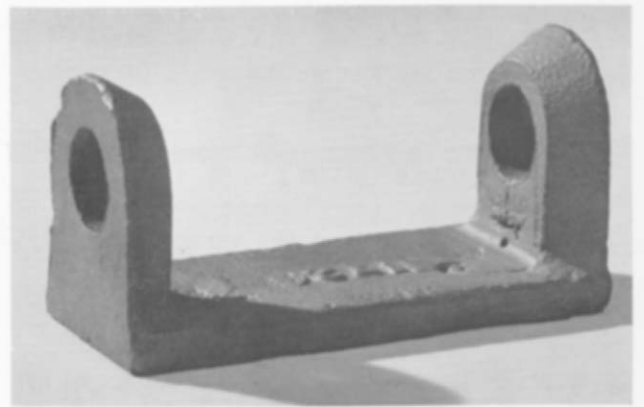
Figure 2—Photograph of Sheave Holder.

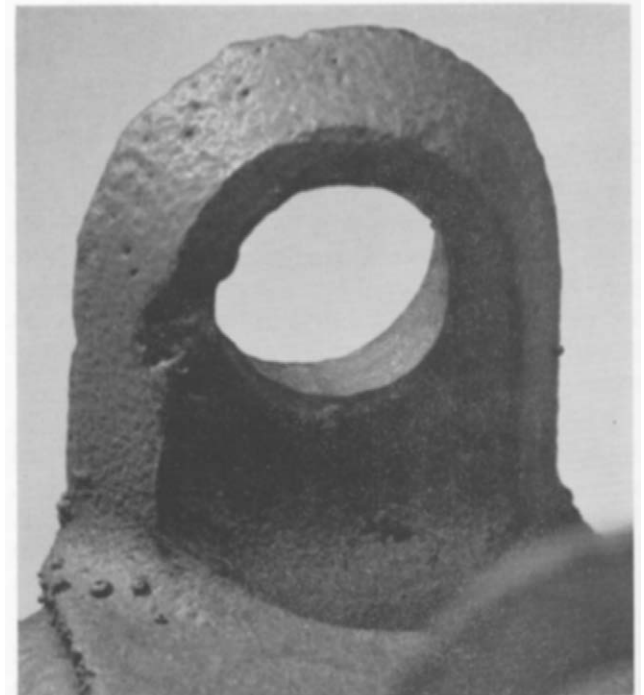
Figure 3—Slag inclusions in cored hole area.

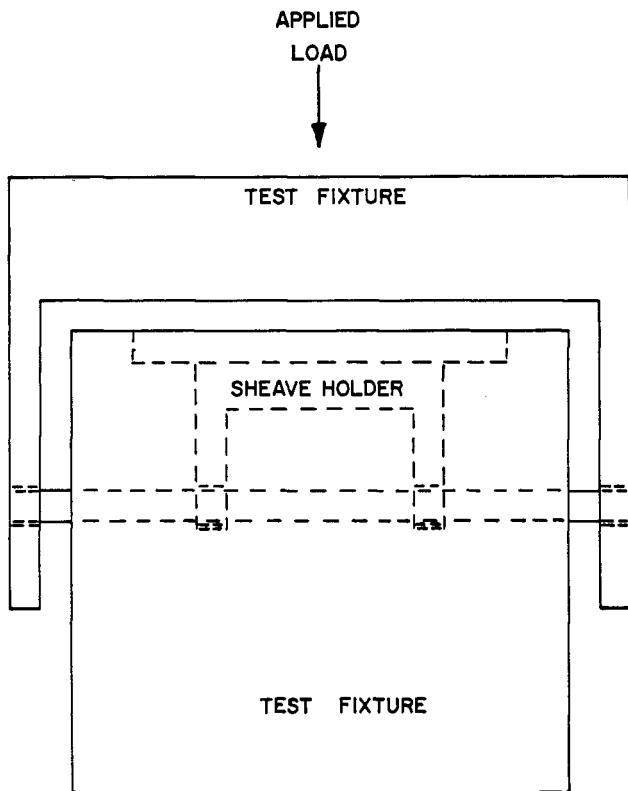
Figure 4—Fatigue test arrangement indicating test fixture, position of applied load and Sheave Holder casting.

The service load on the Sheave Holder varied from zero to a maximum that depends on the particular service conditions. The castings were tested with a preload of 660 pounds because of the limitations of the Amsler Pulsator used in the fatigue testing. The pulsator operated at a frequency of 500 cycles per minute. The small scale fatigue specimens were tested on a R. R. Moore fatigue machine at a frequency of 10,000 cycles per minute.

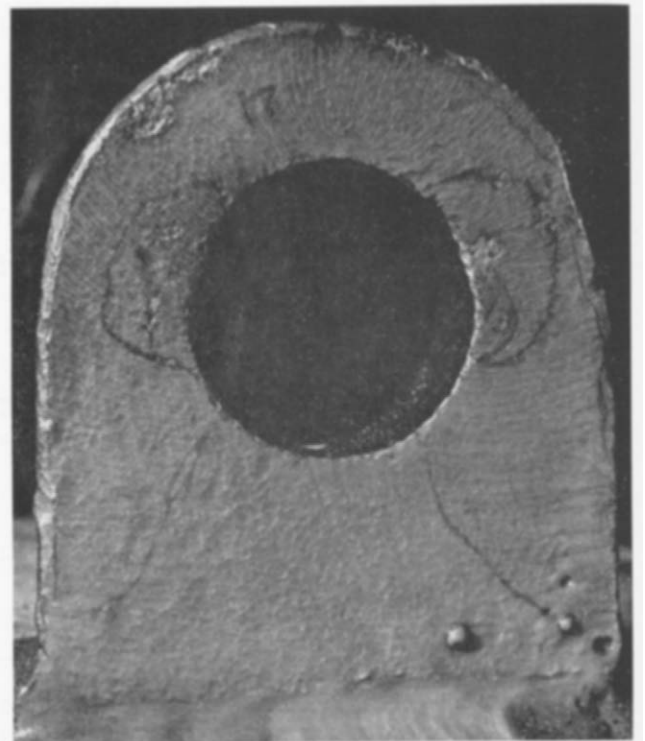
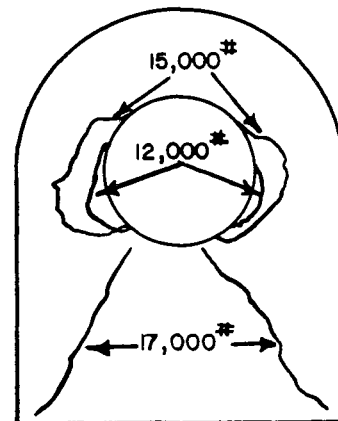
Figure 5—Stresscoat crack pattern for Sheave Holder.

Strain gages were located as shown in Figure 1 on the basis of the brittle lacquer test. The stresses being uniaxial were calculated by multiplying the experimental strain readings by Young's modulus. Stresses obtained experimentally and the calculated stresses are shown in Figure 6. A good correlation between experimental and calculated stresses (finite plate theory) was obtained at all gage locations except after yielding at the location of Gage 1.

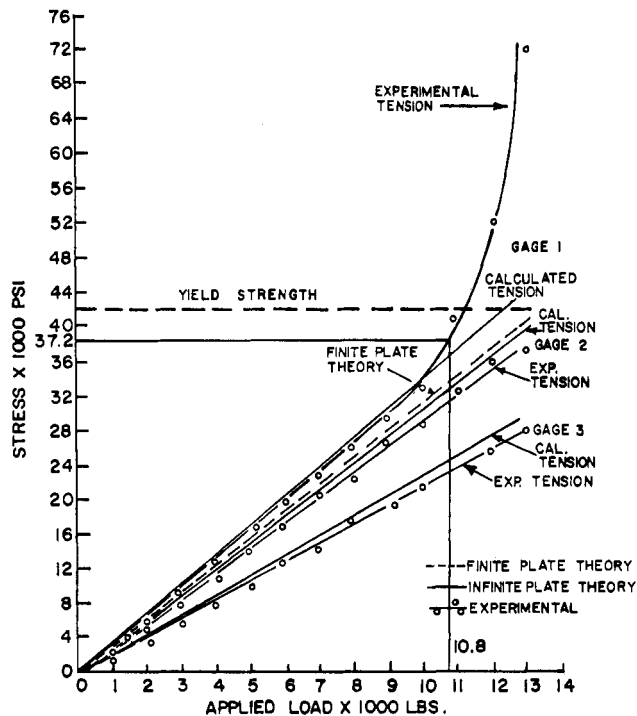
Figure 6—Calculated and measured stresses versus applied load at strain gage locations for Sheave Holder.

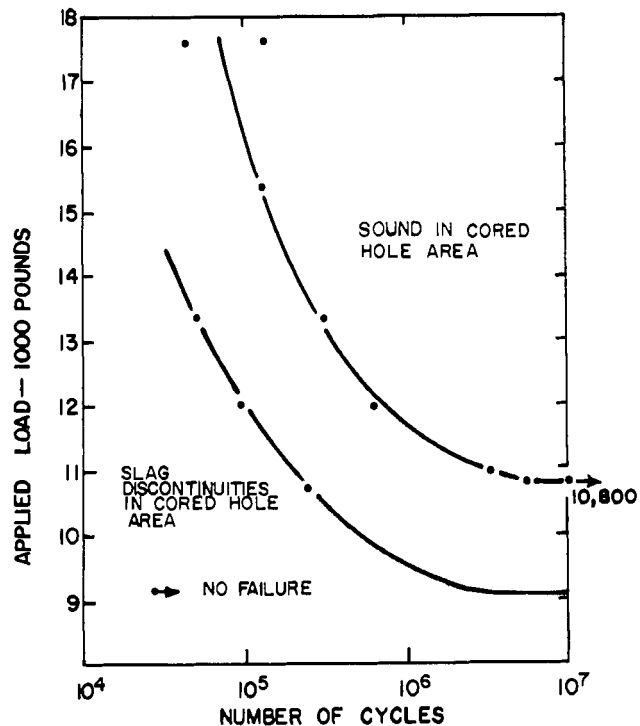
Figure 7—Load versus cycles to failure plot for Sheave Holder casting.

Fatigue Tests . . . The load versus cycles to failure curves obtained from the fatigue tests conducted on the Sheave Holder casting are plotted in Figure 7. The endurance limit was selected at five rather than ten million cycles in order to expedite testing with the slow operating Amsler Pulsator. The lower number of cycles for the endurance limit does not introduce significant error since these curves for this type of steel attain a constant stress level after two or three million cycles. Fatigue failure occurred by fracturing completely through one side of the cored hole area of the casting as indicated in Figure 8. None of the castings failed through the fillet area where the major surface discontinuities and internal discontinuities were located. Failure, therefore, resulted because of the maximum stress con-

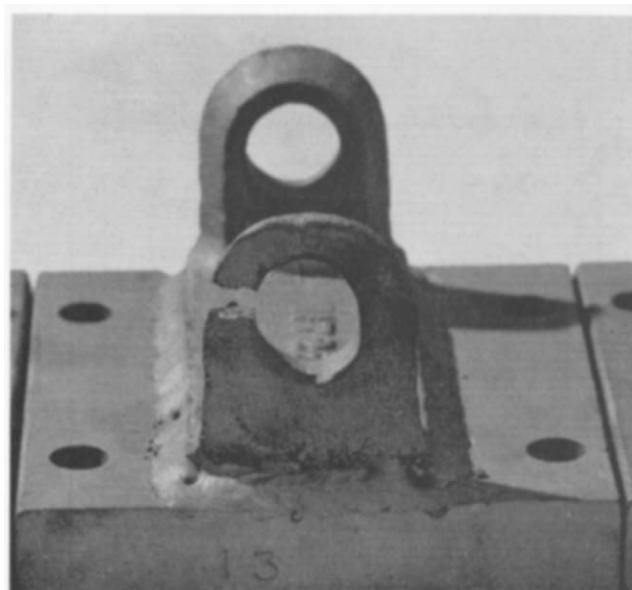
Figure 8—Location of the fatigue failures for the Sheave Holder casting.

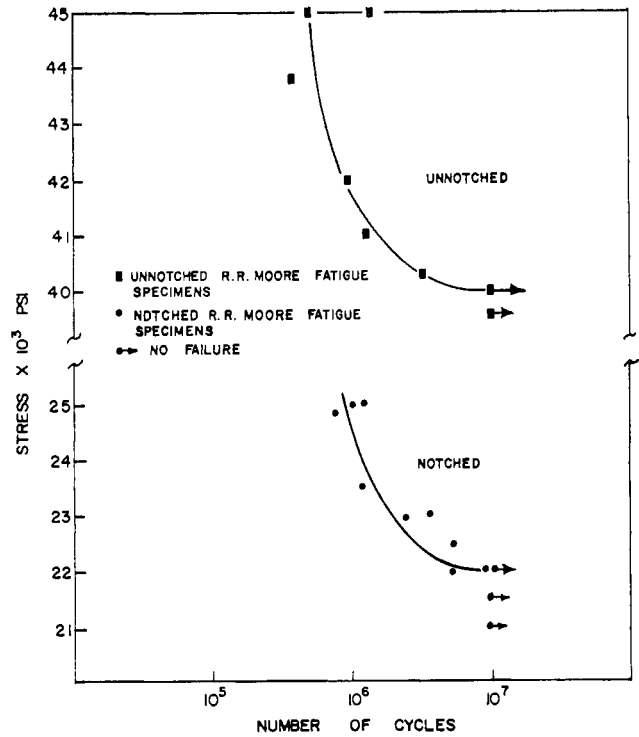
Figure 9—S-N curves for R. R. Moore fatigue specimens for a normalized and tempered 0.33 percent carbon cast steel.

The results of the R. R. Moore notched and unnotched fatigue specimens have been summarized in Table 2 and the S-N curves shown in Figure 9.

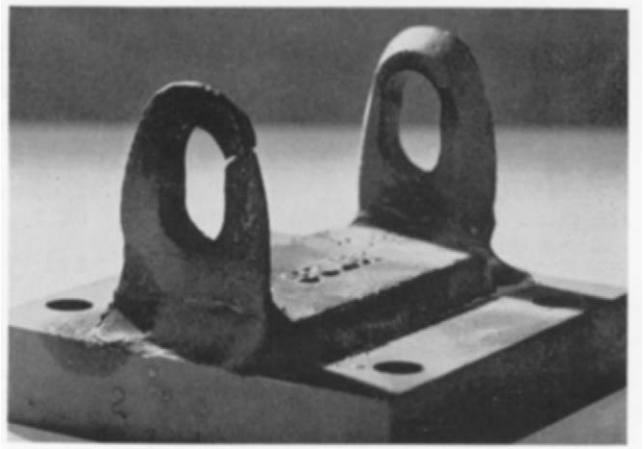
Figure 11—Location of fracture on Sheave Holder from 18,300-pound load. Also showing shrinkage at fillet area.

Stress analysis of the Sheave Holder steel casting showed that the maximum stress area of the casting as employed in service is located in the cored opening area of the flanged sections and not in the fillet area which is the position of the

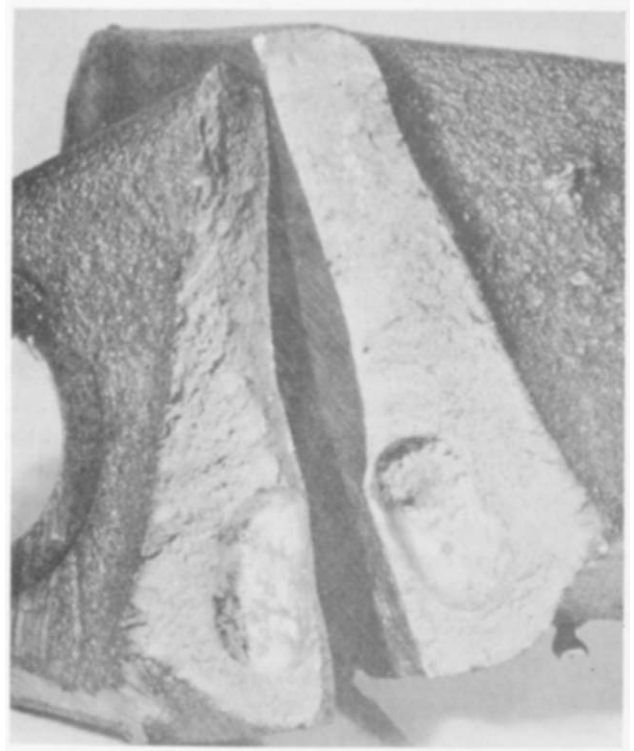
Figure 13—Severe gas porosity in base of Fulcrum Bracket.

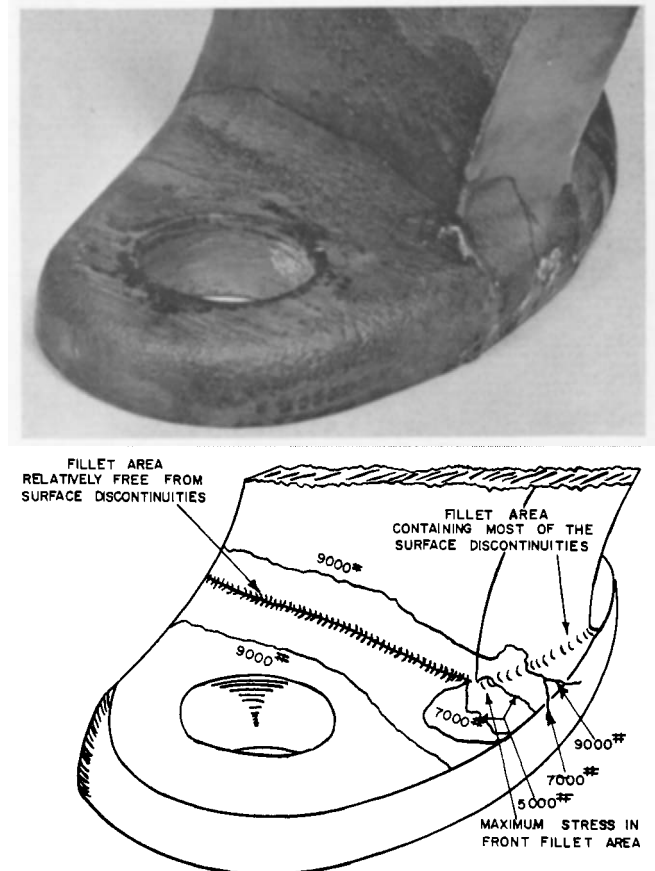
Figure 17—Stresscoat crack pattern for Fulcrum Bracket.

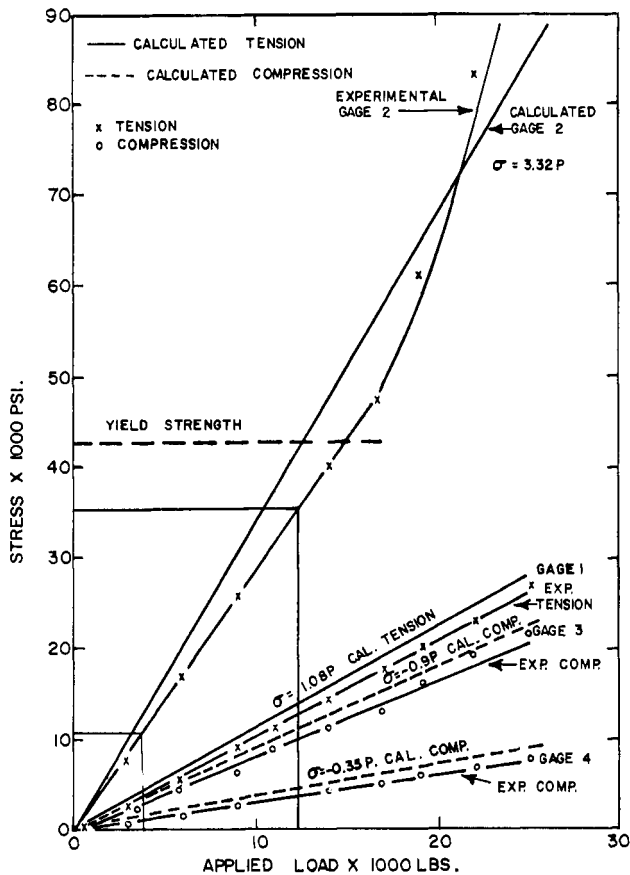
Figure 18—Calculated and measured stresses versus applied load at strain gage locations for Fulcrum Bracket.

Strain gages were located as shown previously in Figure 12 on the basis of the brittle lacquer test. Since the stresses were essentially uniaxial, they were calculated by multiplying the experimental strain reading by Young's modulus. Stresses obtained experimentally and the calculated stresses are shown in Figure 18. A good correlation between experimental and calculated stresses was obtained at all gage locations except

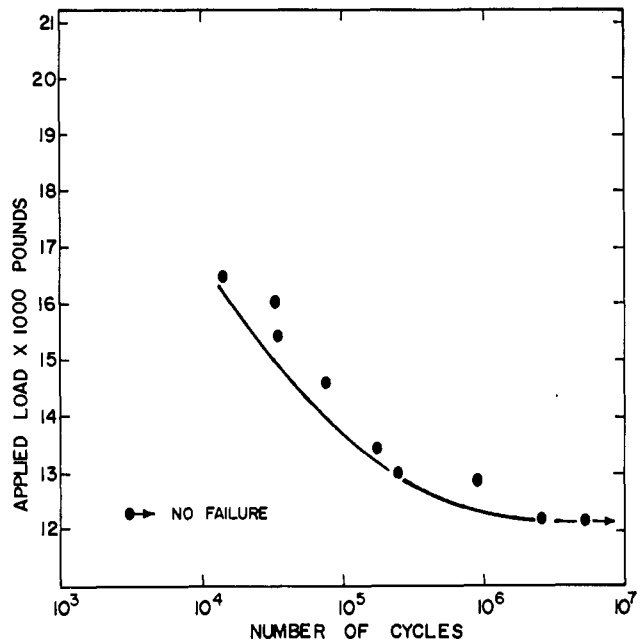
Figure 19—Load versus cycles to failure for Fulcrum Bracket casting.

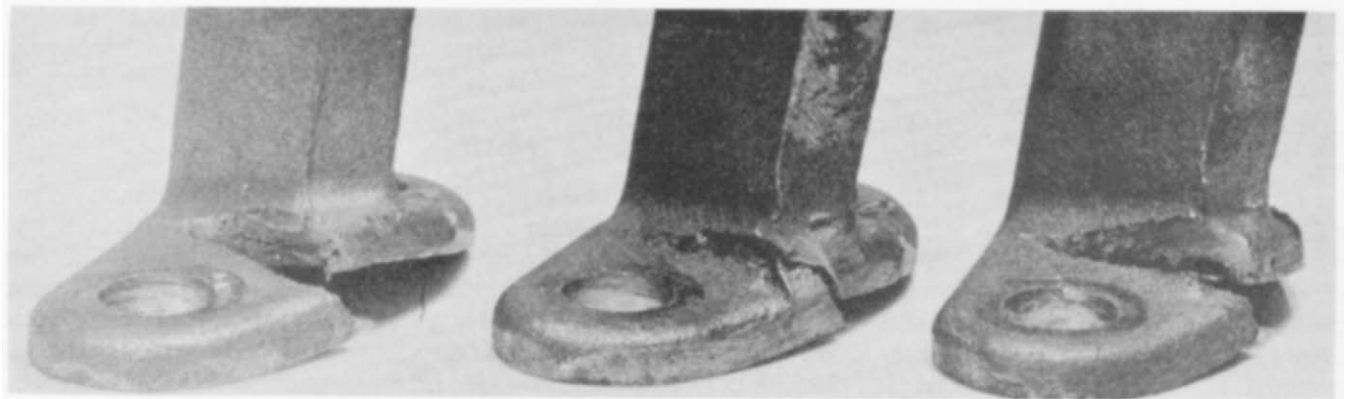
Figure 20—Location of fatigue failures in Fulcrum Bracket.

The fillet on one side of the flange blends into the base of the bracket, while the fillet on the front side shows the full contour and yields a maximum stress concentration factor of 3.32. Fatigue failures of all the Fulcrum Bracket castings, shown in Figure 20, occurred in the area of the fillet which does not blend into the base and

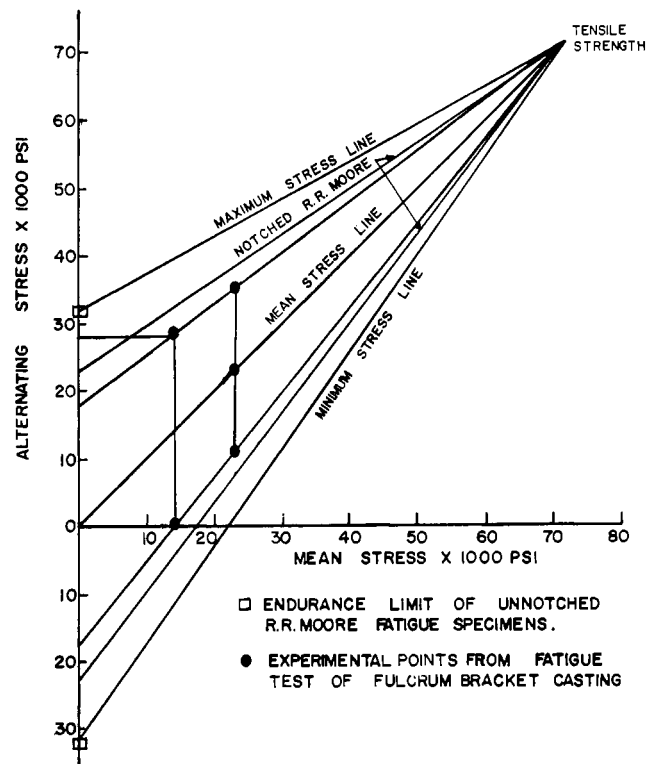
Figure 21—Modified Goodman diagram from fatigue tests of Fulcrum Bracket.

The fatigue results can be converted to actual service loading conditions by constructing and employing a modified Goodman Diagram as shown in Figure 21. The position of the maximum and minimum stress lines at zero mean stress are constructed using the R. R. Moore unnotched endurance limit for the carbon cast steel of 32,000 psi. The maximum and minimum stress lines, also at zero mean stress, for the R. R. Moore notched specimen are shown at the 23,000 psi value.

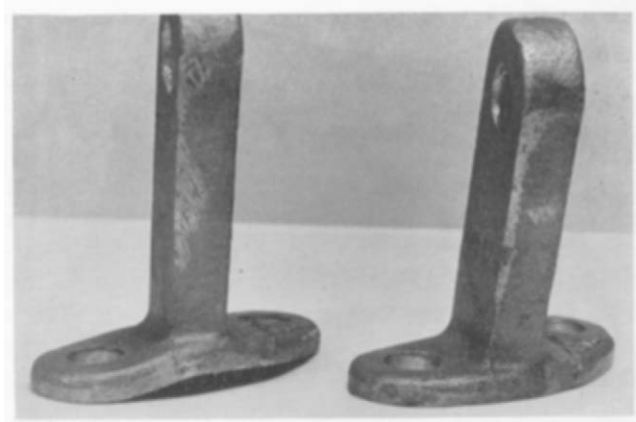
Figure 22—Result of 25,000-pound load on Fulcrum Bracket.

The casting was designed to sustain a load of 3833 pounds. This figure is the 3333-pound maximum service load plus a fifteen percent increase for emergency service. The load to failure in fatigue at 10,000 pounds is a safety factor 3.0 on the designed loading and 2.6 on emergency fatigue loading. The load to failure in the static test at 25,000 pounds is 6.5 times the design load. Both are rather high safety factor design values for steel castings.

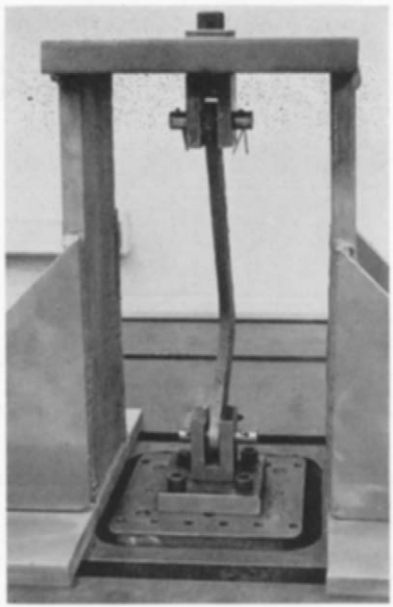
Figure 25—Test fixture in experimental stress analysis and fatigue tests of Hanger casting.

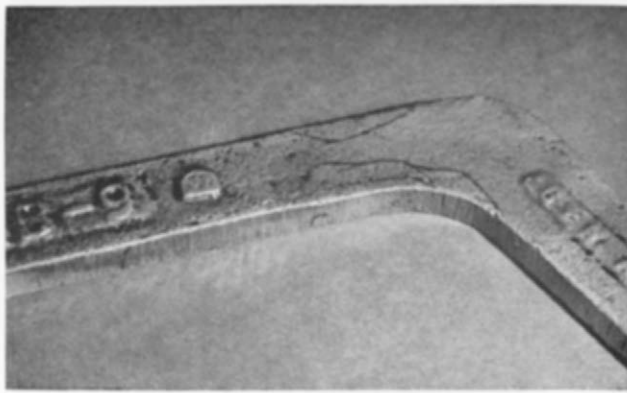
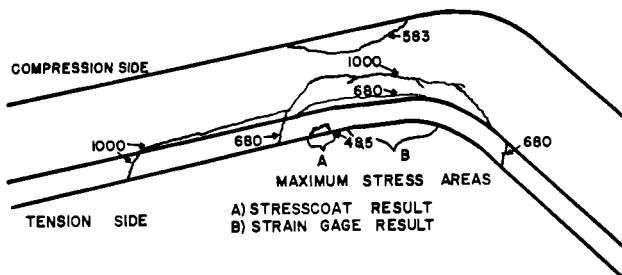
Figure 26—Stresscoat patterns produced in loading the Hanger casting.

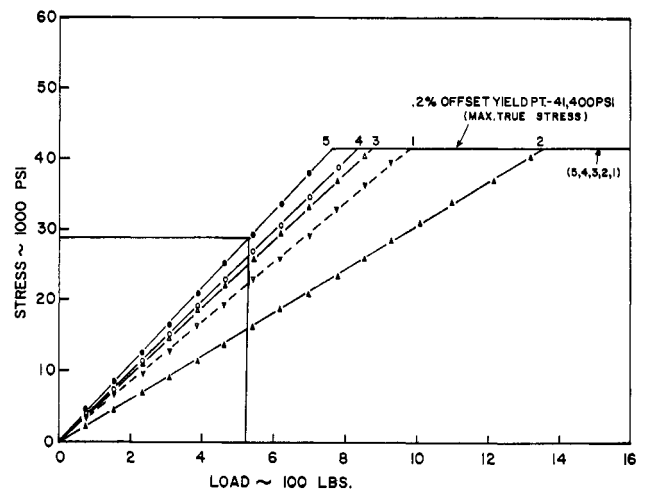
Figure 27—Stress versus applied load at various strain gage locations on Hanger casting.

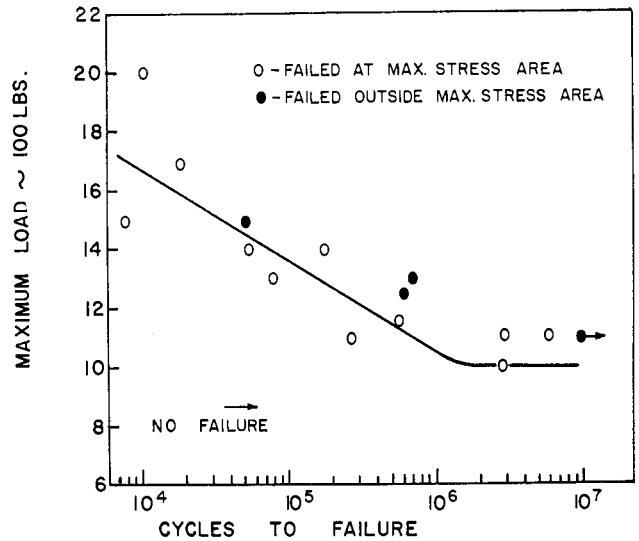
Figure 28—Maximum load versus cycles to failure for fatigue testing of Hanger casting.

The maximum load versus cycles to failure curve obtained from fatigue tests conducted on the Hanger casting is plotted in Figure 28. An endurance limit of 1000 pounds was obtained for the Hanger casting. Of the 15 castings tested, 11 failed in the section between gages 4 and 5. (See Figure 23.) This behavior was consistent with the fact that this position was the area of highest stress. The remaining four castings (represented by solid data points in Figure 28) failed in the vicinity of gage 2.

The maximum design load for the Hanger casting is 400 pounds. The load to failure in fatigue as shown in Figure 28 is 1000 pounds giving a

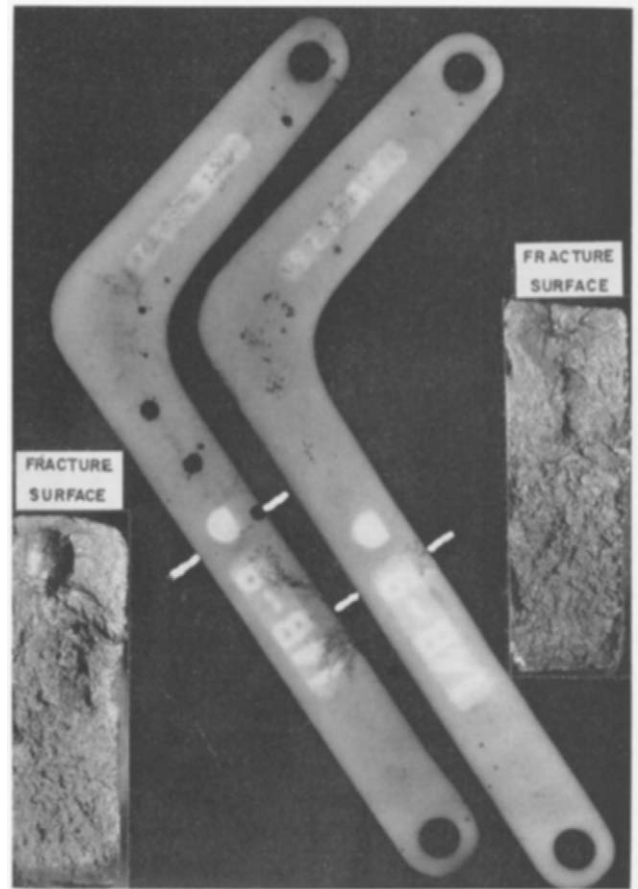
Figure 29—Comparison of radiographs and fracture surfaces of two Hanger castings tested in fatigue.

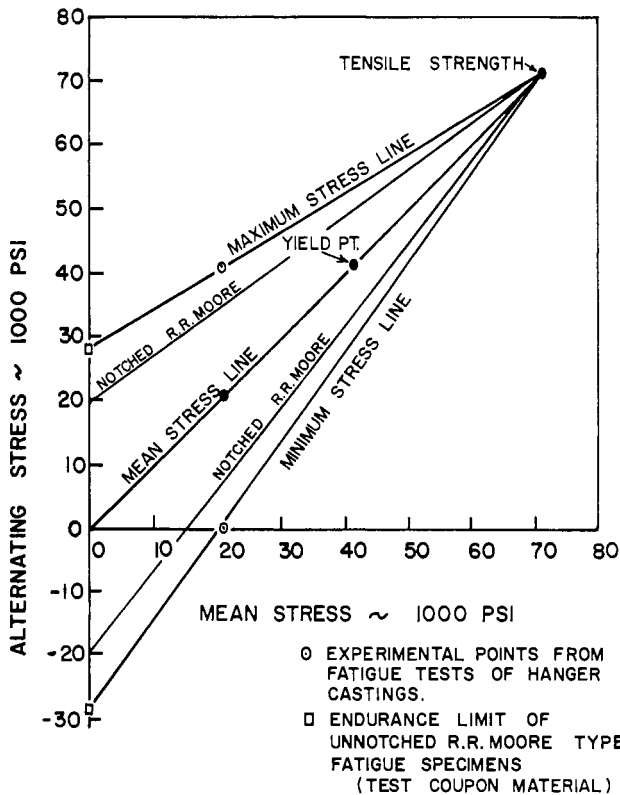
Figure 30—Modified Goodman diagram for fatigue testing of the cast steel Hanger castings.

The fatigue test results can be converted to actual service loading conditions by constructing and employing a modified Goodman Diagram as shown in Figure 30. The position of the max-

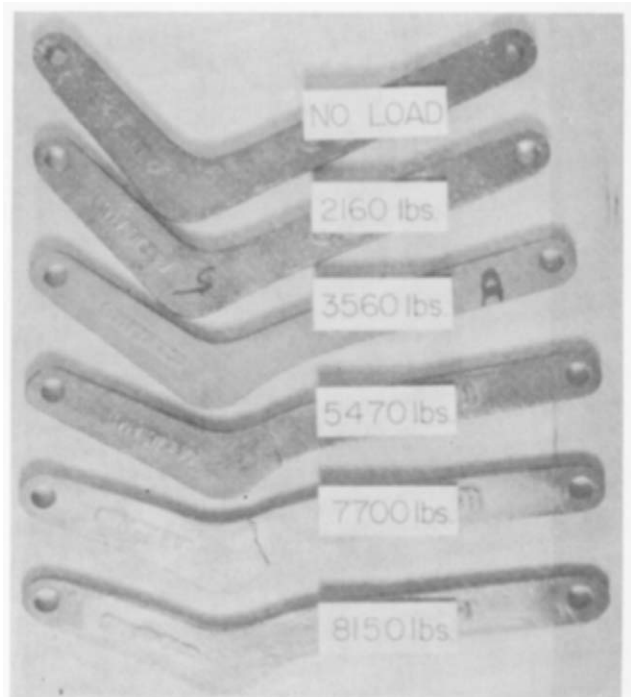
Figure 31—Appearance of cast steel Hanger castings after the application of various static loads.

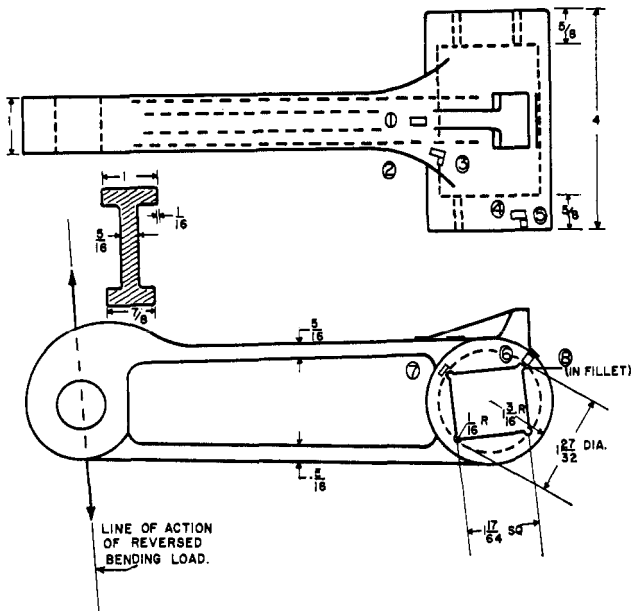
Figure 32—Dimensions of Lever casting and locations of strain gages.

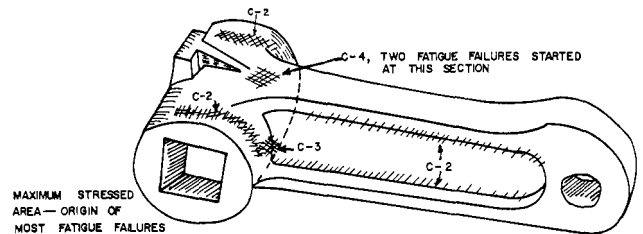
Figure 33—Location and severity class of continuities in the Lever castings.
C-2 to C-4 internal shrinkage of classes 2 to 4 ASTM Reference Radiographs E-71
Porosity to Class 1 observed in a few castings in dispersed areas.

Radiography and magnetic particle examination were used to determine the discontinuities in the Lever casting though the castings were not ordered to nondestructive test requirements. Entrapped slag and gas porosity of Class 1, ASTM E-71 were found widely dispersed in a few castings. Internal shrinkage of Classes 2,3 and 4 was found at locations indicated on Figure 33.

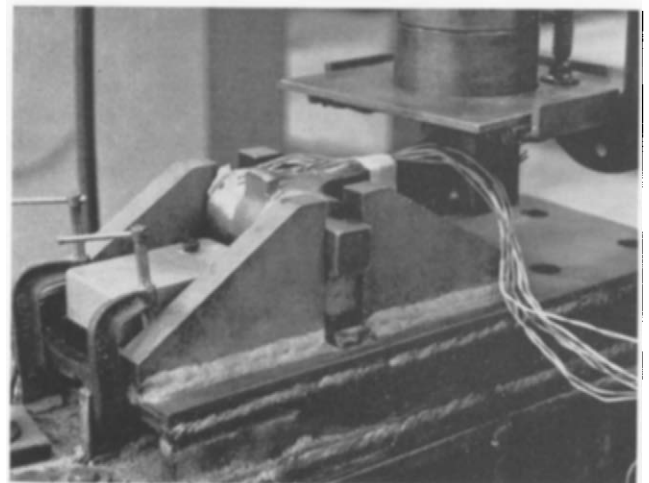
Figure 34—Fixtures for static and fatigue testing of the Lever casting.

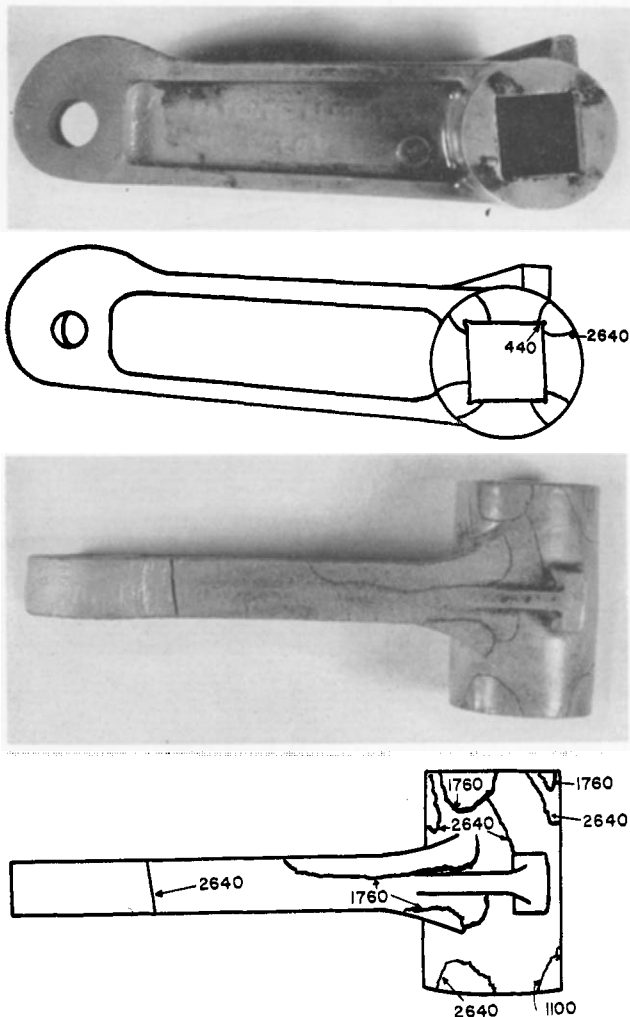
Figure 35—Crack patterns produced in the Stresscoat applied to the Lever casting.

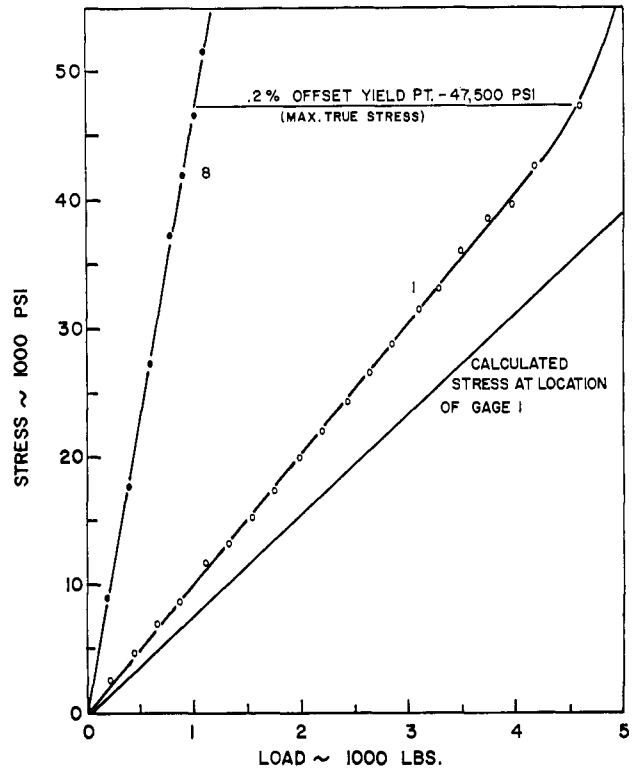
Figure 36—Stress versus applied load at locations of gages 1 and 8 on Lever casting.

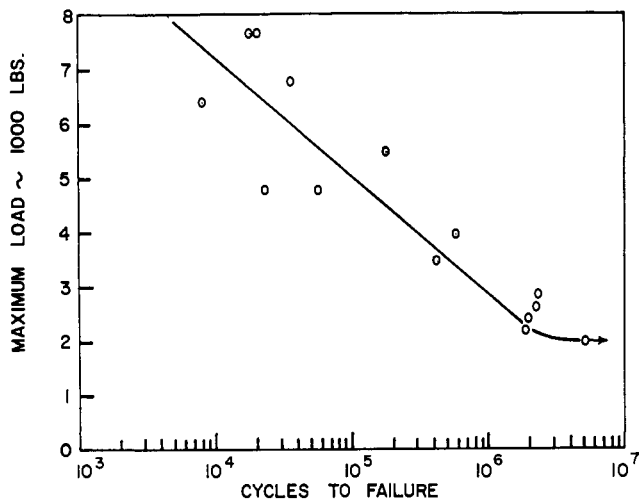
Figure 38—Maximum load versus cycles to failure for the Lever castings tested at a minimum load of 660 pounds.

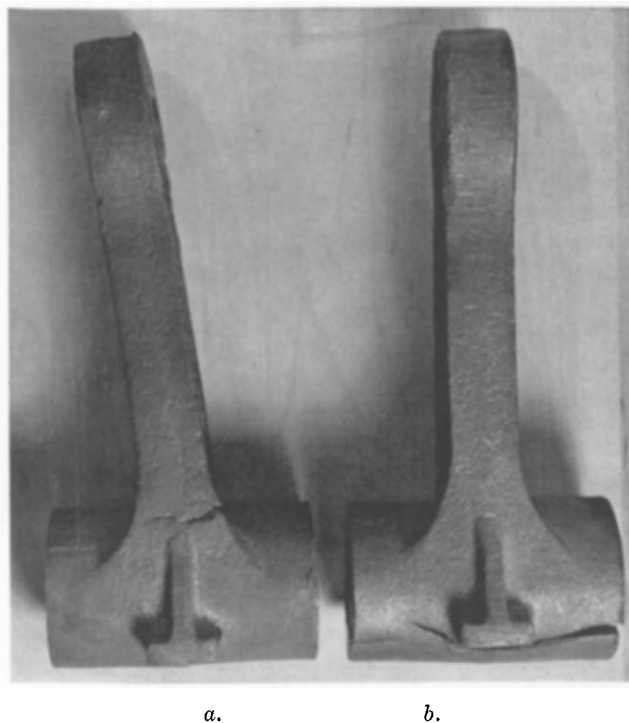
a. b.
Figure 39—Types of fatigue failure found in the Lever castings
(a) One of two castings loaded at 7700-pound maximum load after 17,300 cycles.
(b) Typical failure exhibited by all other Lever castings at lower maximum loads and larger number of cycles.

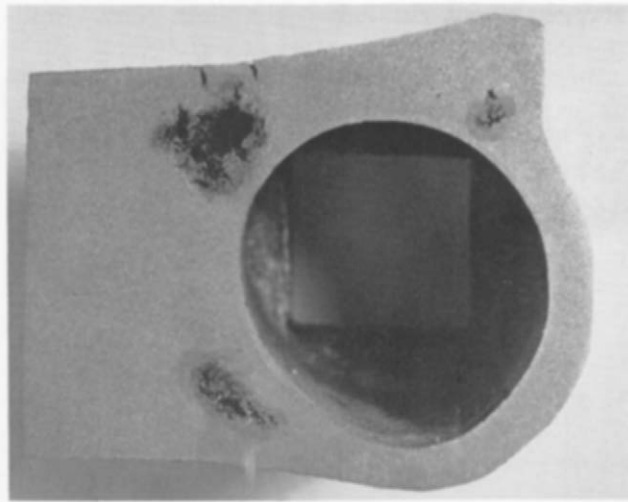
Figure 40—Macroetched cross section of the Lever casting through the center of the rib section on the barrel. This casting failed in fatigue at a high load of 7,700 pounds maximum load after 19,900 cycles.

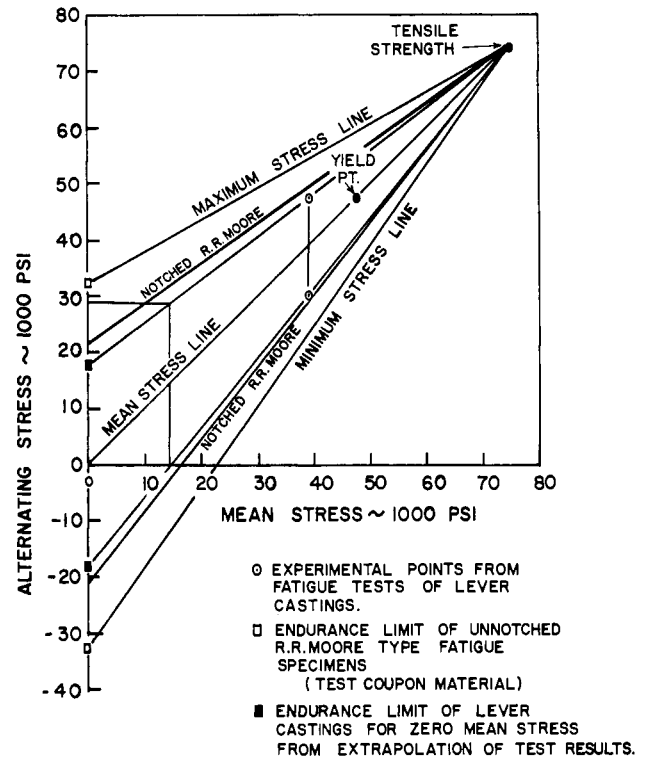
Figure 41—Modified Goodman diagram for the fatigue testing of Lever castings.

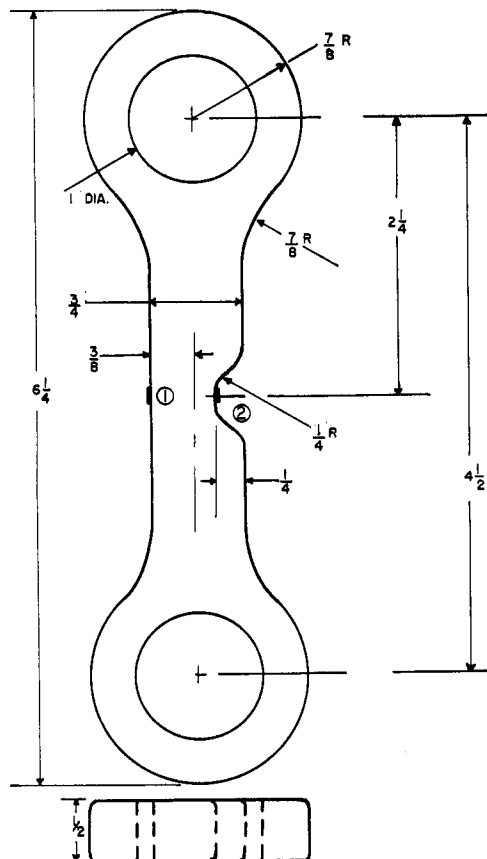
Figure 42—Dimensions of Trip Link casting and locations of strain gages.

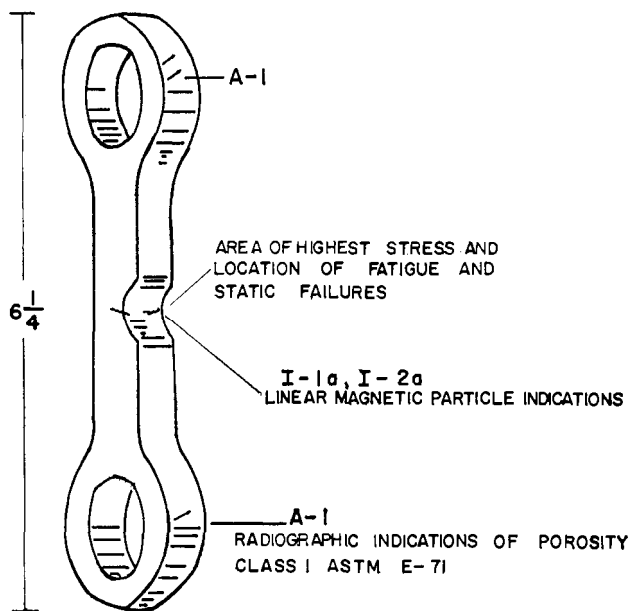
Figure 44—Position and severity of discontinuities in Trip Link casting.

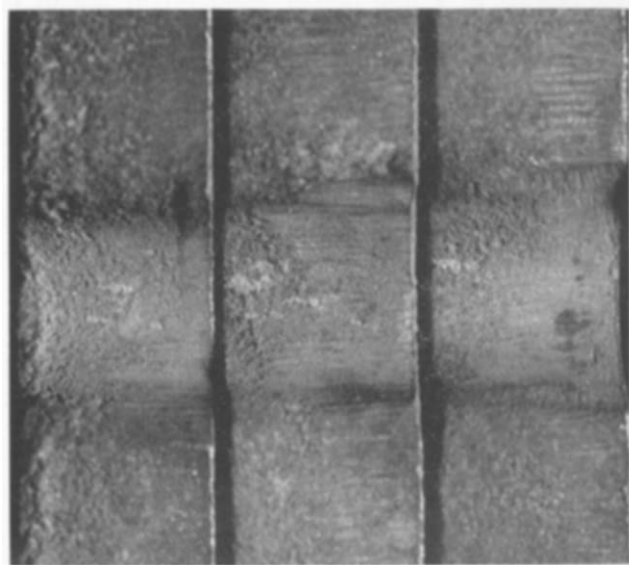
Figure 45—Magnetic particle indications of hot tears in Trip Link casting.

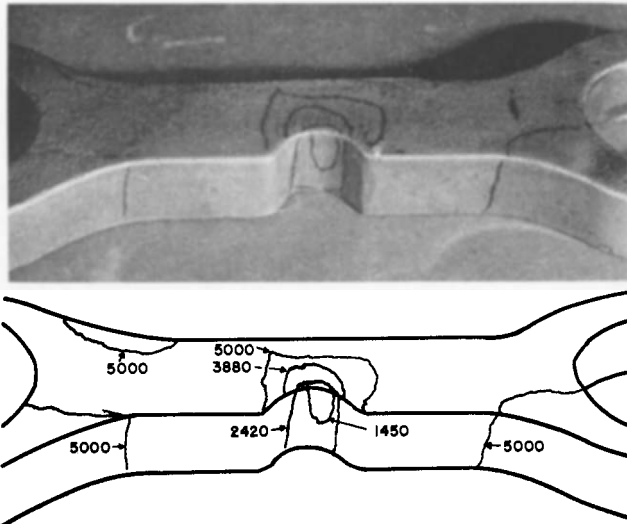
Figure 47—Crack patterns produced in brittle lacquer test of Trip Link casting.

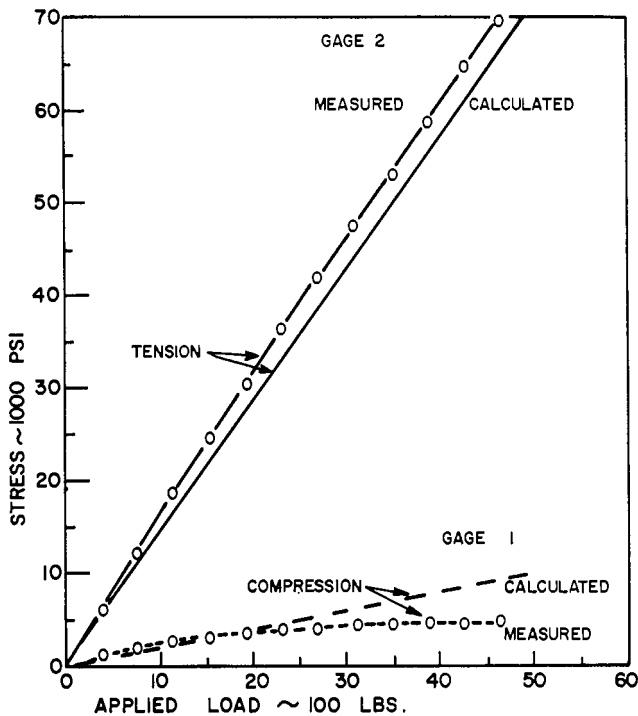
Figure 48—Calculated and measured stresses versus applied load at strain gage locations on Trip Link casting.

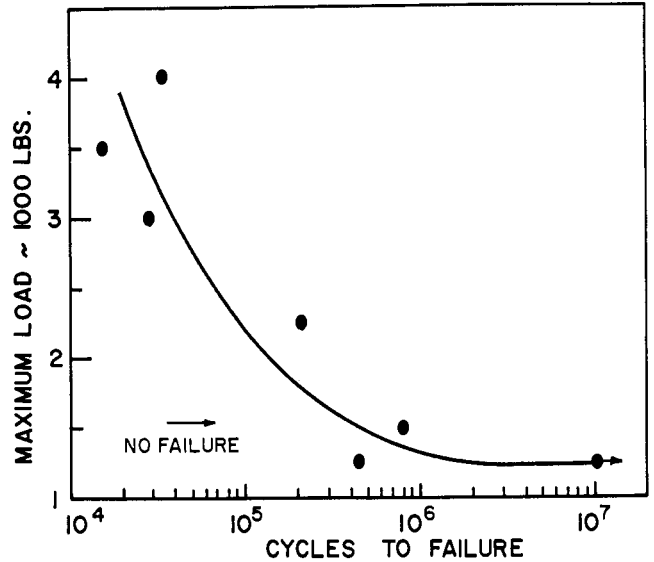
Figure 49—Maximum load versus cycles to failure for fatigue tests of Trip Link castings.

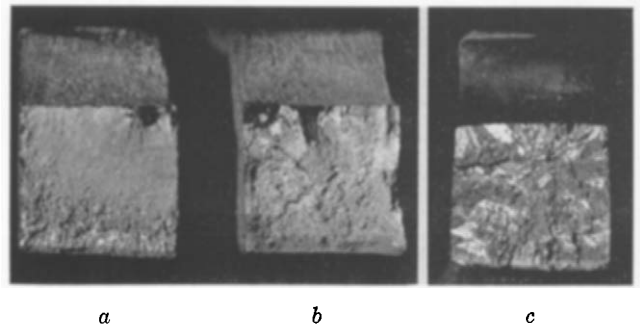
Figure 50—Fracture surfaces of Trip Link casting broken in fatigue and static loading.
