**THE EVALUATION OF DISCONTINUITIES
IN COMMERCIAL STEEL CASTINGS BY
DYNAMIC LOADING TO FAILURE
IN FATIGUE**

**A RESEARCH PROJECT AT CASE INSTITUTE
OF TECHNOLOGY**

Steel Foundry Research Foundation

Rocky River, Ohio February, 1967

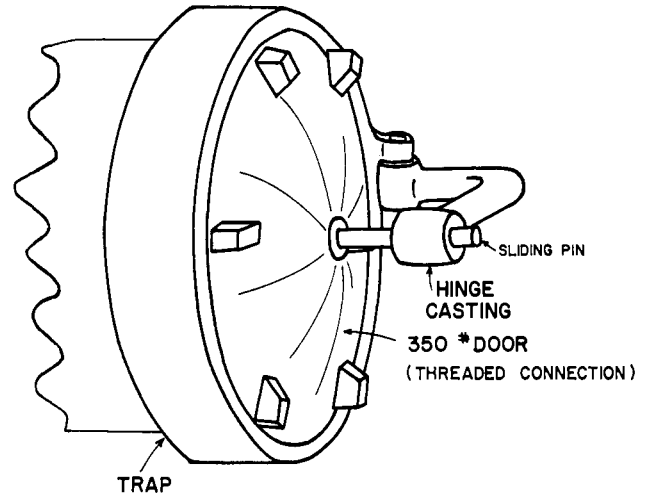
Figure 52—Service application of the cast steel Hinge.

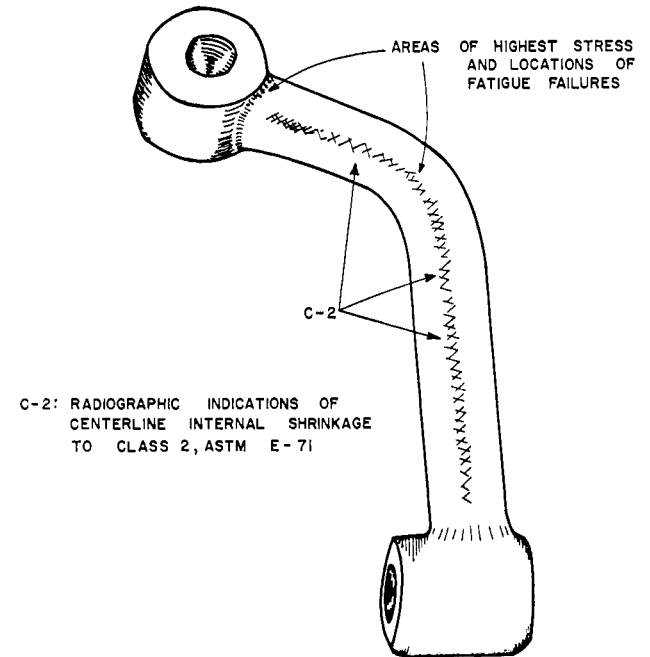
Figure 53—Positions and severity of discontinuities in the Hinge casting and areas of fatigue test failures.

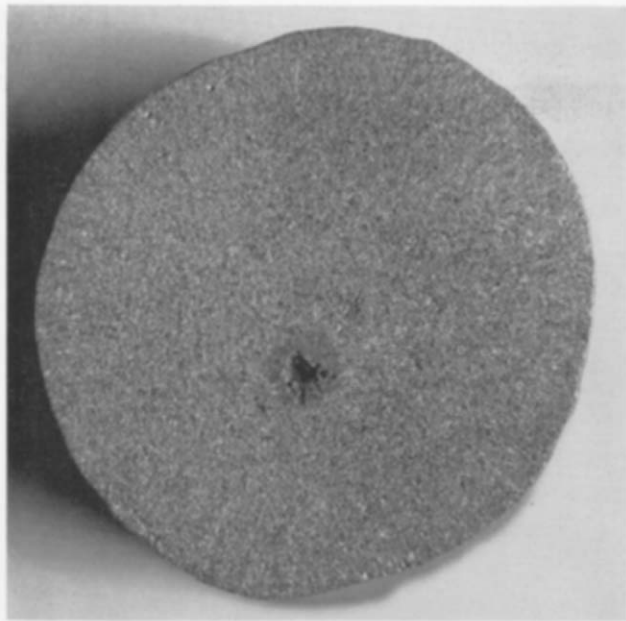
Figure 54—Macroetched cross section of the Hinge casting (Location of gage 5-6).

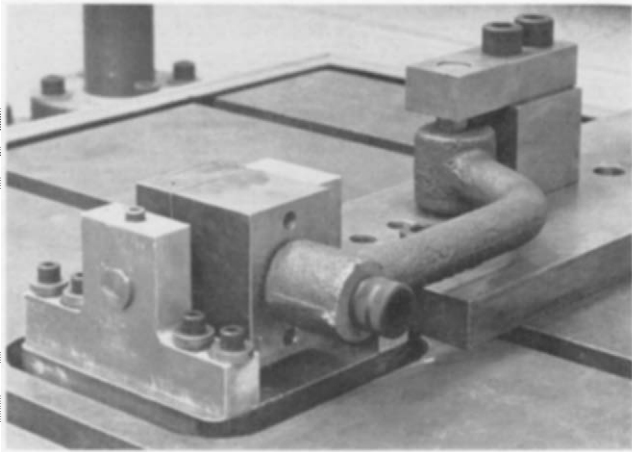
Figure 55—Test setup used in experimental stress analysis and fatigue tests of the cast steel Hinge.

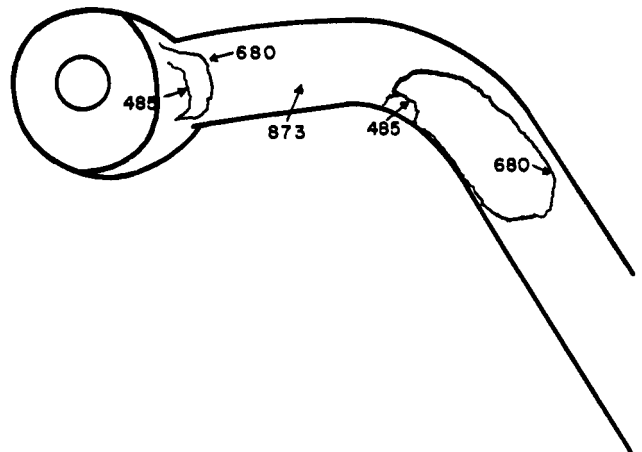
Figure 56—Stresscoat crack patterns produced in the brittle lacquer testing of the Hinge casting.

The first cracks in the Stresscoat appeared at a load of 485 pounds. The sketch, Figure 56, in-

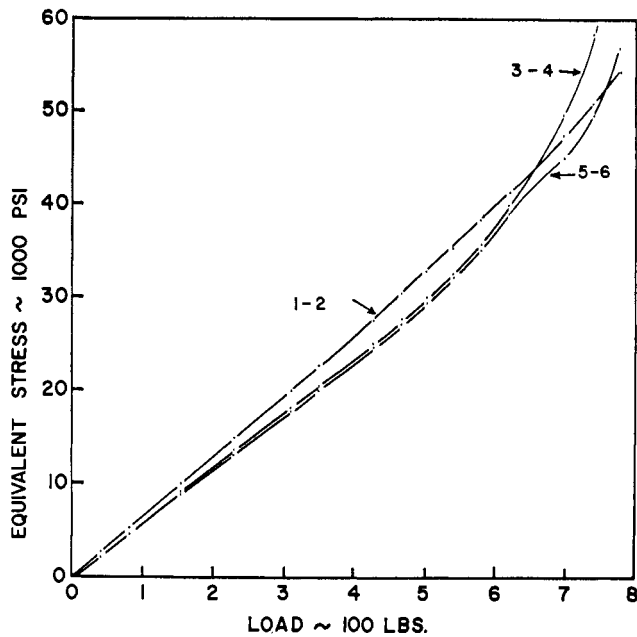
Figure 57—Equivalent stress versus applied load at strain gage locations on the Hinge casting.

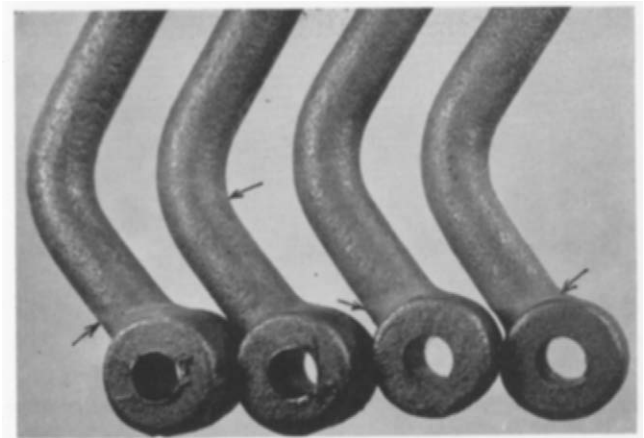
Figure 58—Magnetic particle testing indications of fatigue failures in the cast steel Hinge.

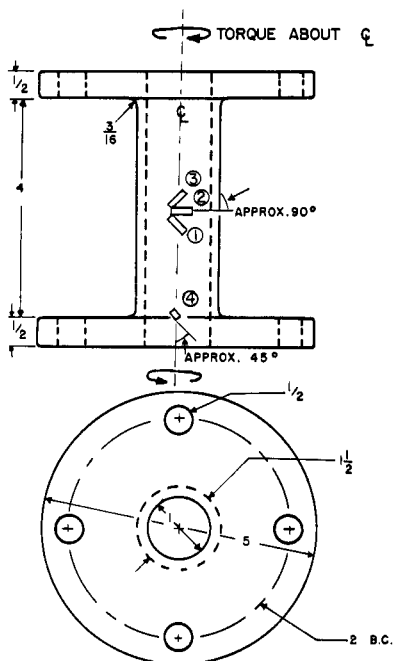
Figure 59—Dimensions of Flange casting showing location of strain gages and type of loading used.

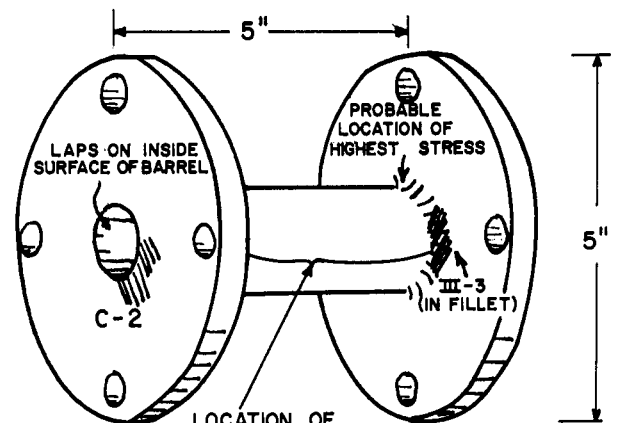
- LOCATION OF
FATIGUE FAILURES;
DISCONTINUITIES OF TYPE III-3, V-1
- C-2 : RADIOGRAPHIC INDICATIONS OF
INTERNAL SHRINKAGE TO CLASS 2, ASTM E-71
- III-3 : MAGNETIC PARTICLE INDICATIONS OF INCLUSIONS
TO DEGREE 3, ASTM E-125
- V-1 : MAGNETIC PARTICLE INDICATIONS OF POROSITY
TO DEGREE 1, ASTM E-125

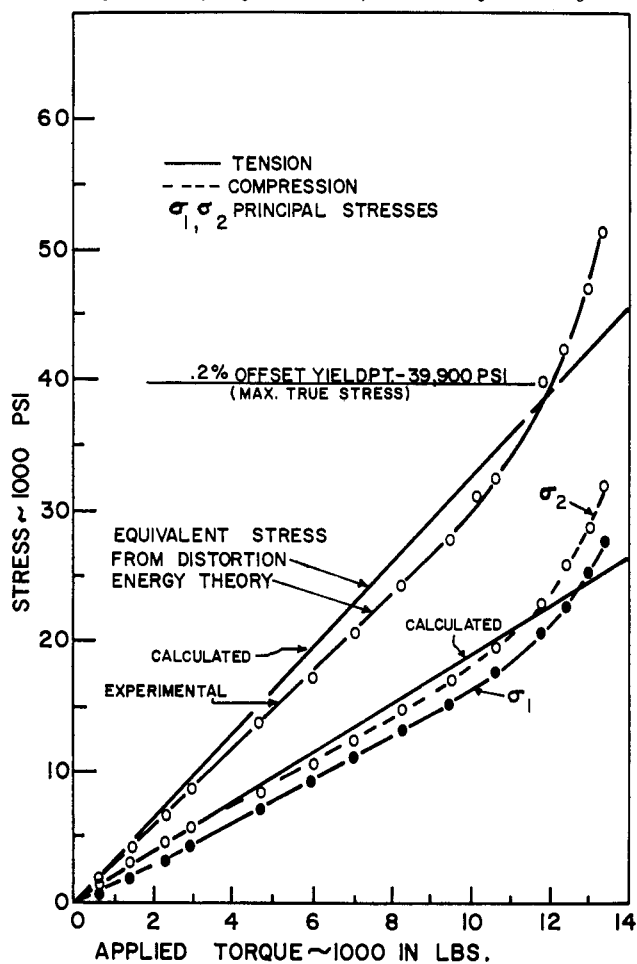
Figure 62—Principal and equivalent stresses versus applied torque at strain gage rosette locations on the Flange casting.

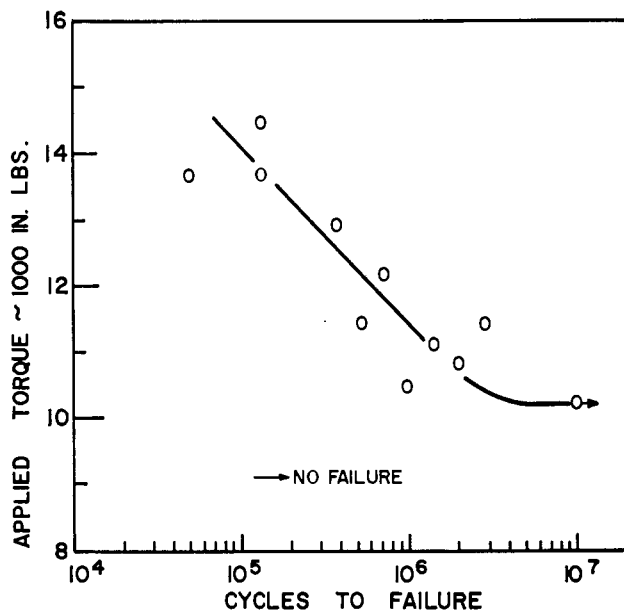
Figure 63—Applied Torque versus cycles to failure for reversed torsion fatigue tests in the Flange Casting.

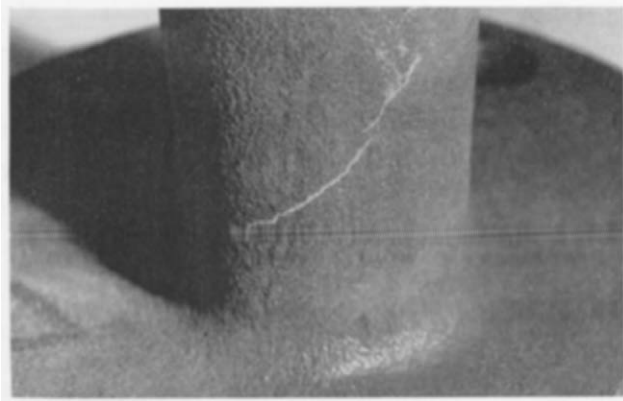
Tensile failure.

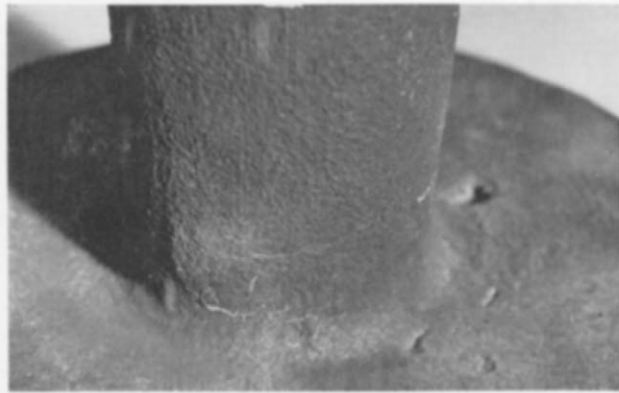
Transverse shear failure.

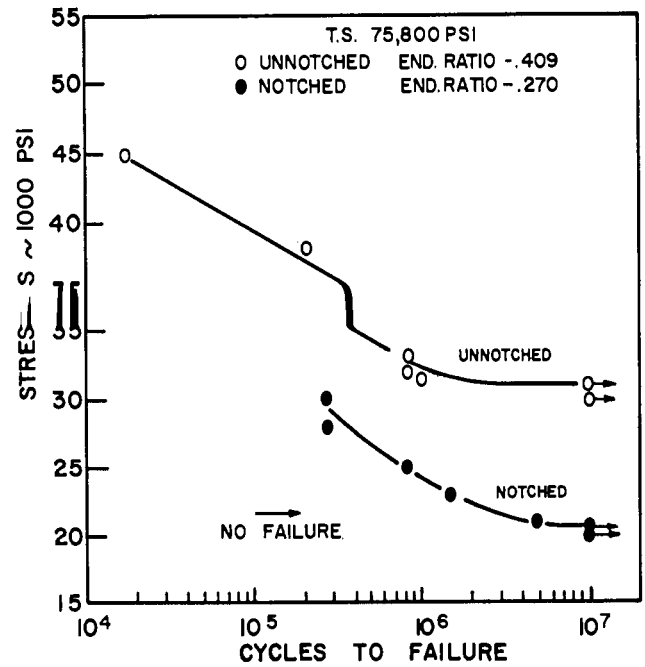
Figure 65—S-N curves for R. R. Moore fatigue specimens machined from cast steel coupons cast with the Flange castings.

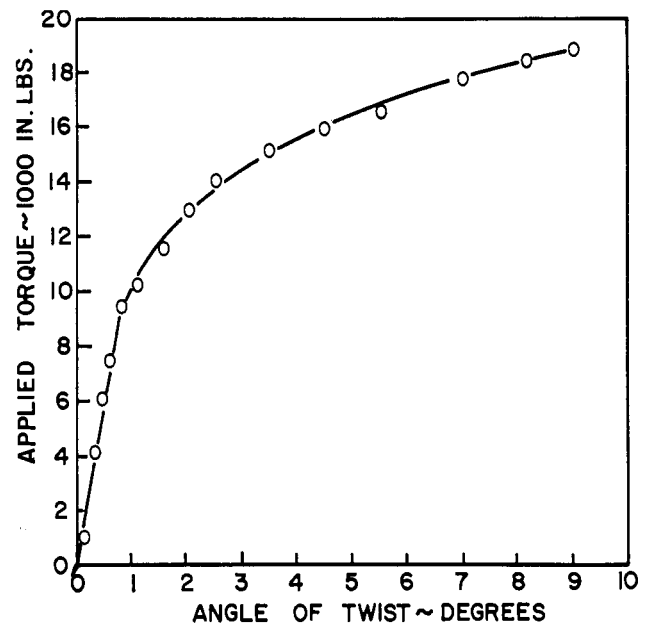
Figure 66—Torque-twist curve obtained in static test of the Flange casting.
