Reducing Crack Potential in CA40

Daniel Harris

Steel Founders' Society of America
Technical & Operating Conference
December 7-10, 2022

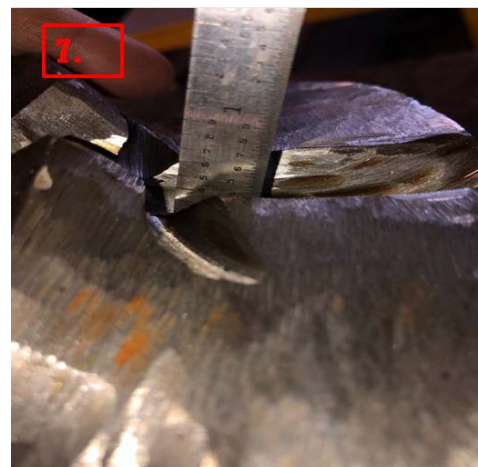
Figure 8- Defect excavation

A sample was chosen for mechanical excavation to determine representative depth. The original indication identified on a contact area appeared as axial running down the top flight with a smaller transverse indication at the radius of the flight and body intersection. Figure 8 details the excavation of the subject casting. The excavation revealed that there is a sub-surface continuation and networking of the cracks at various depths.

- Crack completely removed at 1/2" material depth.

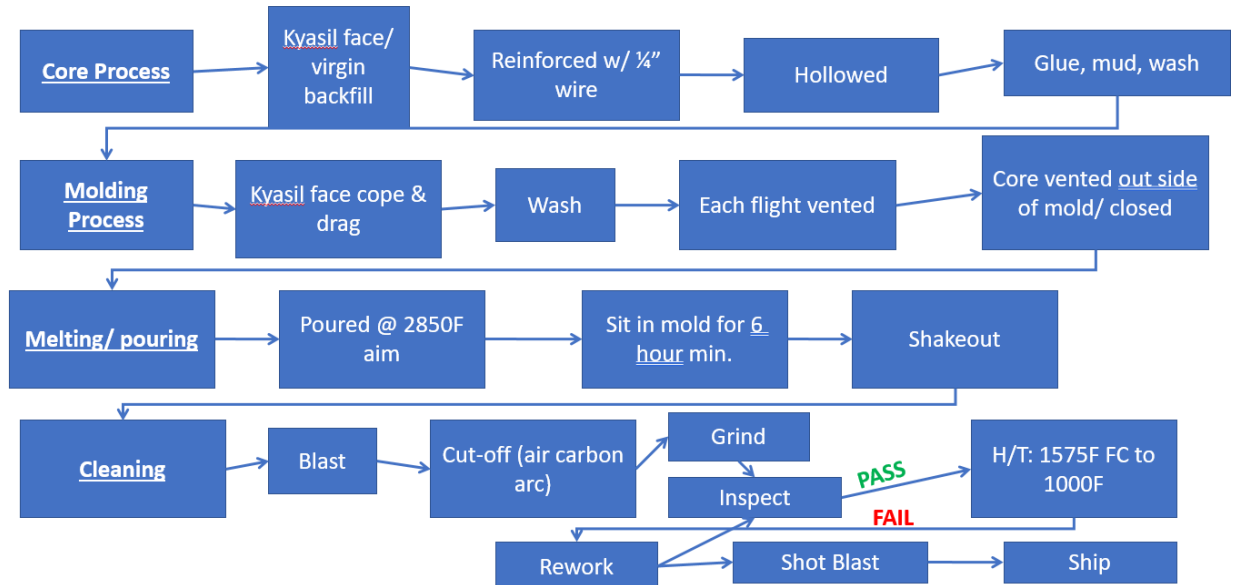
Figure 9- Current state process

Figure 9 below details the process as in the current state. While the contributing factor is unclear, a noteworthy observation is that of the cut-off and grinding processes. Rigging and risering is removed via air arc gouging, and afterwards the castings undergo a swing grinding operation during which the bulk of the contact material is removed. After swing grinding, they are transferred onto the final hand finishing operations.

Air arc gouging and swing grinding are seemingly aggressive processes concerning the potential for higher heat input at the cast surfaces. A handful of castings were inspected after cut-off and before grinding only to reveal that little to no cracking was present at this point. Following swing grinding, cracks were identified at suspect areas.

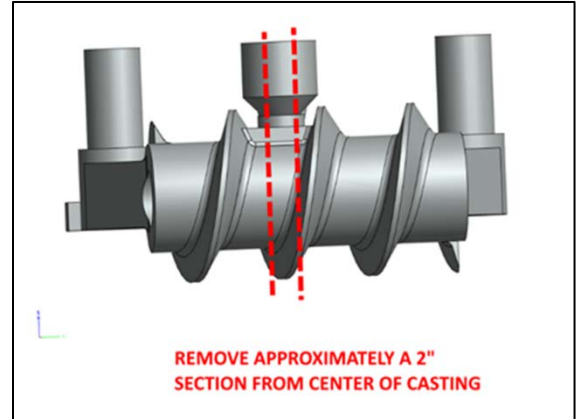
Figure 10- Sectioning of castings

It was elected to pursue a more technical approach in order to observe material structure, and consequently determine metallurgical abnormalities that may attribute to cracking. [3] castings were chosen for sectioning and subsequent metallography. The castings remained fully rigged and risered and had no processing done. The sectioning was conducted via water jet process, so as not to induce any extreme temperatures into the material and consecutively maintain a completely as-cast structure. Figure 10 illustrates the sectioning. The center riser was chosen for study since this is the most consistent area that cracks are identified.

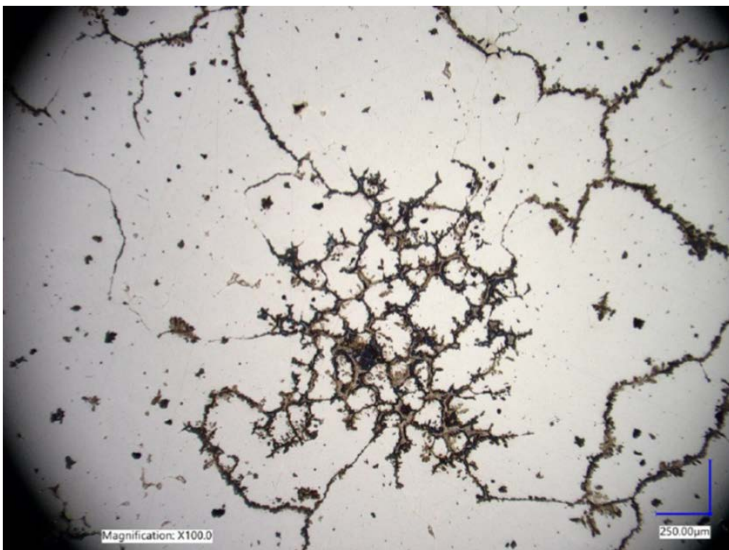
Figure 16- After etching, magnification: X100

The location 1 sample was then etched with Vilella's Reagent, and a darker network was observed. Figure 17 shows locations of EDS 3 and 4, both of which contained elevated carbon, manganese, zirconium, and oxygen.

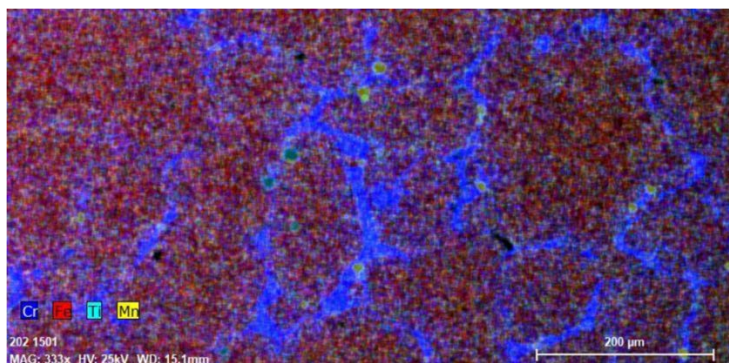
Figure 18 (repeated)- Location 1, EDS mapping

Color coded EDS mapping shown in Figure 18 below displays the highly elevated chromium content in the interdendritic network (blue), which is likely resultant of riser segregation. The remainder of the element matrix appears to be well distributed. All three casting samples exhibited very similar segregation in this region.

Despite several observed factors related to overall material cleanliness, there was no chromium carbide precipitation present at location 2, as compared location 1. Overall, this area exhibited a well homogenized elemental distribution. Figures 18 and 22 below display a direct side-by-side comparison of color-coded EDS mapping to illustrate the drastic difference in the locations.

Location 1 at the area near the riser contact displayed excessive chromium carbide precipitation. Surrounding this network is a region rich in carbon, manganese, zirconium, and oxygen. These carbide phases are brittle, and the density of these phases could lead to process cracking during casting finishing operations such as swing grinding. Location 2 away from the riser exhibits some diffusion of the mold (cored area) and sporadic inclusions, however, *no similar elemental segregation or carbide precipitation is present*. The overall material cleanliness (sporadic inclusions, micro shrink, etc..) that were brought to light during the analysis could be dealt with in different manners but are not of concern for the purpose of this investigation, as most of this area is machined away, and furthermore, there have been no associated concerns regarding these characteristics. It is speculated that adequate heat treatment could solutionize some of these phases.

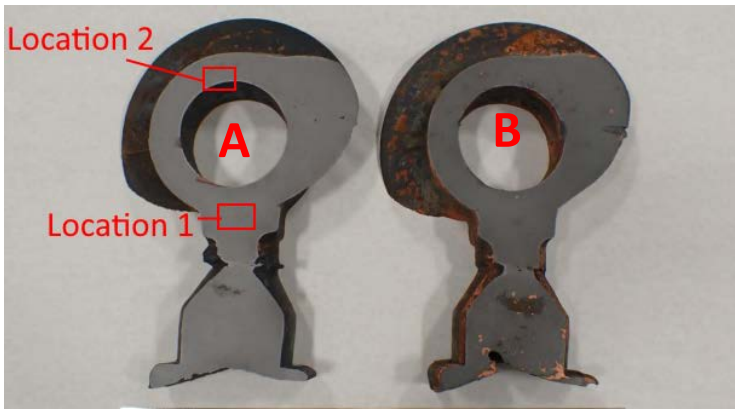
Figure 25- Cut sections

A series of hardness measurements were taken at approximately 1/2" below the cast surfaces. Brinell values ranged from 238 to 249. Though tensile properties are not required in this instance, these values would equate to somewhere around 115,000 psi which would exceed the 100,000 psi requirement in A743 if supplement S12 was specified.

The two cut specimens were surface ground and macroetched. Neither sample displayed any macro segregation, or discontinuities in location 2 opposite of the riser. Both samples did exhibit some shrinkage at location 1 (risered area) towards the base of the riser as expected. Both locations on both specimens display a structure that consists of uniform fine equiaxed grains. Some slight carbon depletion was identified at location 2 adjacent to the cored area on both samples.

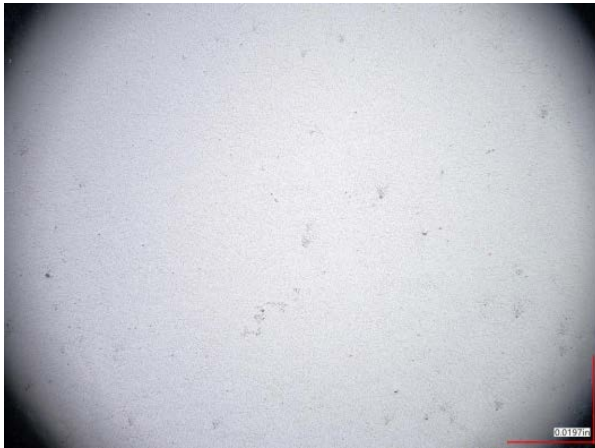
Figure 26- Location 1 Adjacent to riser. Unetched

Figure 26 displays location 1 adjacent to the riser on the first sample and is representative of that of the second sample. Both samples were very similar in features. No discontinuities are present.

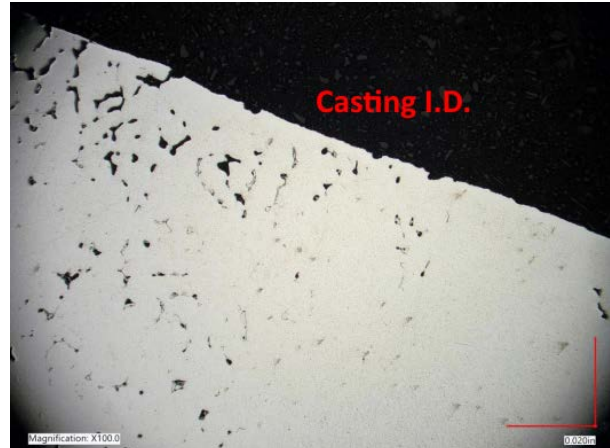
Figure 27- Location 2, opposite of riser. Unetched

Figure 27 displays location 2 opposite of the riser on the first sample and again, is representative of that of the second sample. Some minor shrinkage porosity is present, similar to that observed on the original as-cast samples, likely resultant of mold diffusion. The overall cleanliness also appears improved.

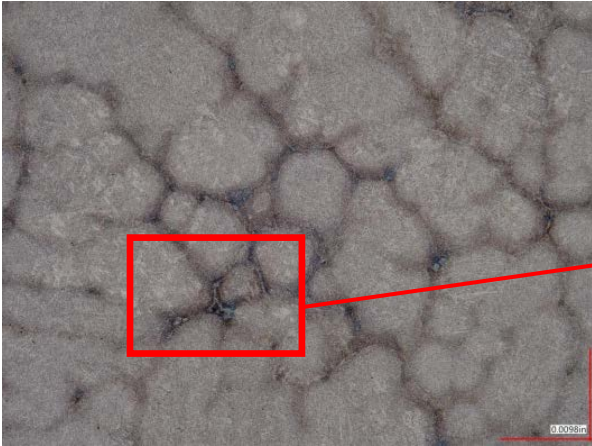
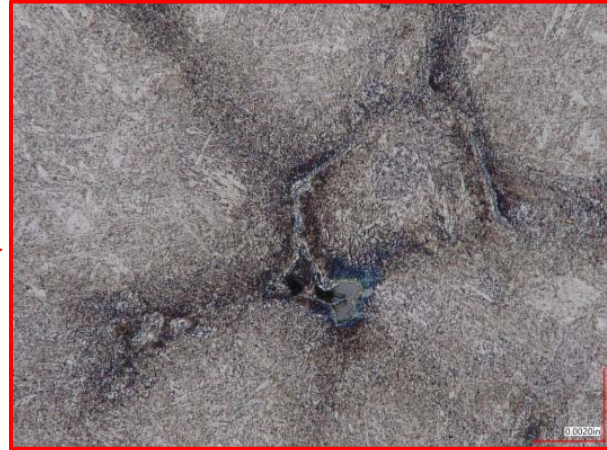
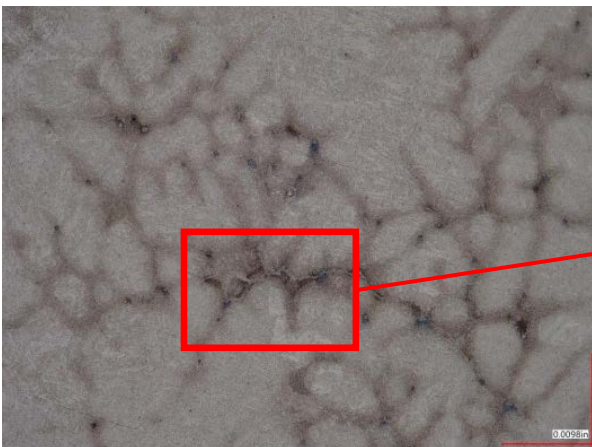
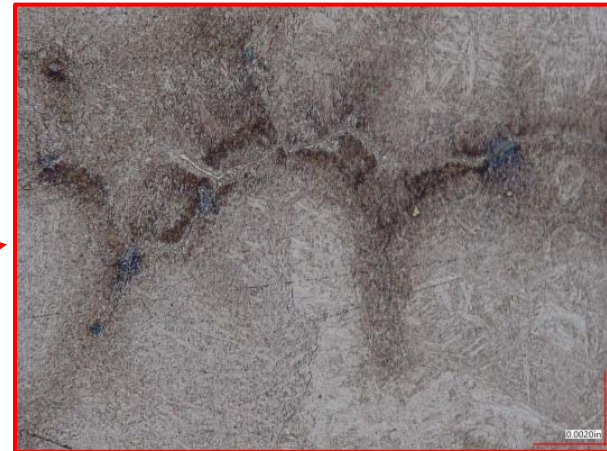
Figures 28-31 on the following page display location 1, adjacent to the riser(s) from both samples after etching. Results from both samples contained very similar features. Some chemical segregation is still present, but very much less than that of the original samples. A light, networked boundary is still visually evident, but again, much less than that previously reviewed. EDS results found chromium content at this area to be around 12.5%- 13.8% which is only slightly elevated in comparison to not only the bulk analysis, but other areas within the casting (recall that original chromium content at this area averaged around 50%). Likewise, carbon content was found to be slightly elevated at approximately 4.5% (recall that originally, carbon content at this area averaged around 10.5%). The overall microstructure consists of tempered martensite, with some carbides remaining in the grain boundaries.

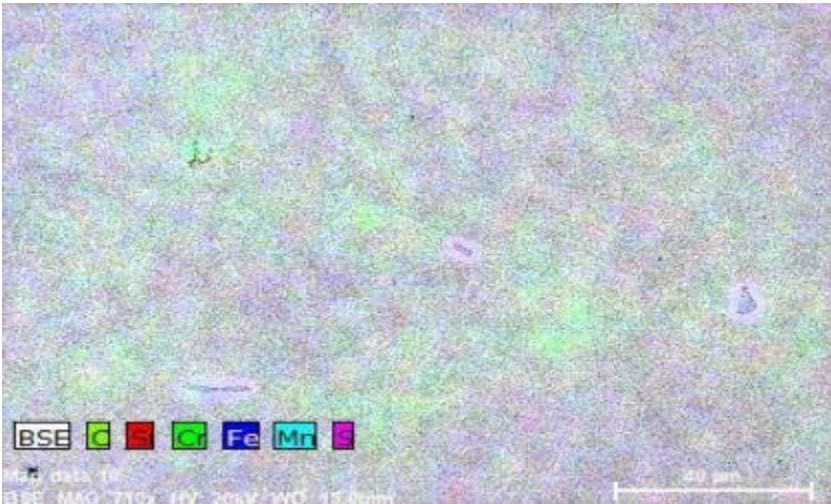
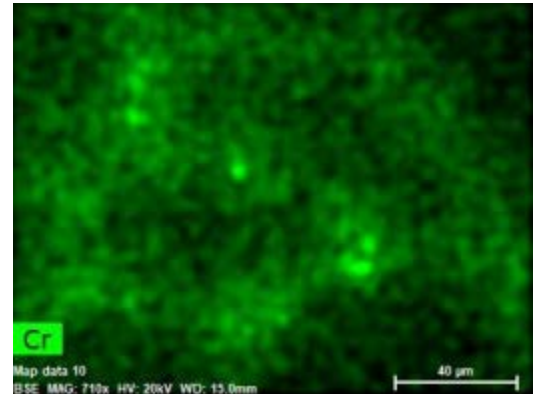
Conventional EDS mapping was again conducted on the samples and showed that the analyzed elements were reasonably uniformly distributed. Only a slight amount of chromium segregation was present at this point, as well as a few sporadic manganese sulfide inclusions. Figures 32 and 33 exhibit color coded mapping of sample B, location 1 adjacent to the riser, with features very similar to that of sample A, and overall, display a fairly homogenized matrix. No contaminant elements such as phosphorus, zirconium, nickel, molybdenum, oxygen, or niobium were detected.
